## **Vibration Diagnostics and Condition Assessment As Economic Tool**

**Zlatan Racic**

### **ABSTRACT**

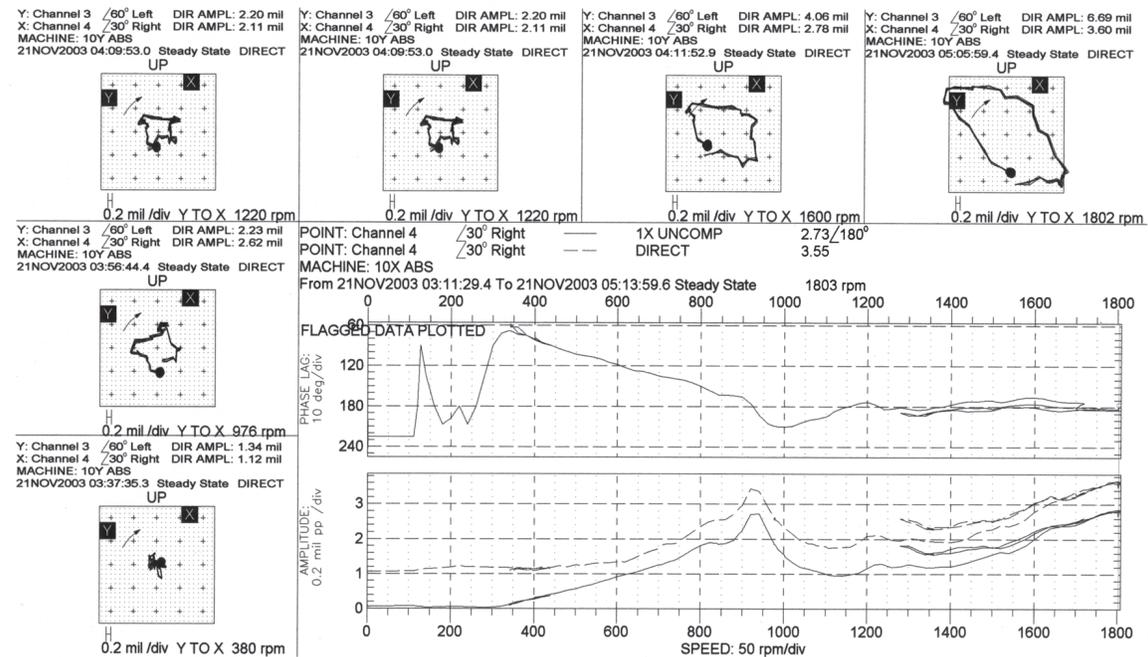
Figure 1a: Bode Plots Bearing 10X

The largest value was 0.001" (1.00mil) at bearing #10. (Fig. 1a). For a rotor this size (i.e. weighing 389,000 lbs) that is equivalent to approximately 6.0 lbs of unbalance at the rotor OD. The centrifugal force of the equivalent balancing weight could correct the elastic deformation amplitude, but it would have NO effect on the eccentricity displacement amplitude measured. The eccentricities can originate from exceeding OEM machining tolerances, forging deformation in operation, or from the assembly. Some effect of the eccentricities can be corrected by high speed balancing in the bunker (more access planes than in the field), some must be corrected by machining and for some, the operating condition must be corrected (proper cooling, or elimination of shorted turns).

These values are visible on Bode Plots and indicate the eccentricity (pk-pk) at the measuring location of the journal. The eccentricities are the fundamental cause of all vibrations. The largest value was measured at journal #10Y at 0.001” (1.0 mil). It is significant that this eccentricity was visible also in the form of residual eccentricity in the transition speed range observed from 1st to 2nd critical, at journals #9 and #10. That confirms that the measured runout at low speed was not just an irregularity at the measuring location, but the true rotor eccentricity. (Fig. 1a)

First critical speed is visible at ~920 RPM peaking at maximum of 0.004” (~4.0 mils) (pk-pk direct). This is an indication of a dynamically very well balanced rotor with good alignment. (Fig. 1a, 1b).

Interesting here is that this “unbalance” at bearing #10 (relative) does not change phase through the speed range from 1000 RPM to 1800 RPM, while the “vibration vector” is proportional to square of speed. The lack of phase change differentiates an eccentricity-caused displacement from a “dynamic” or elastic response and corresponding phase lag. (Fig. 1a, 1b.)

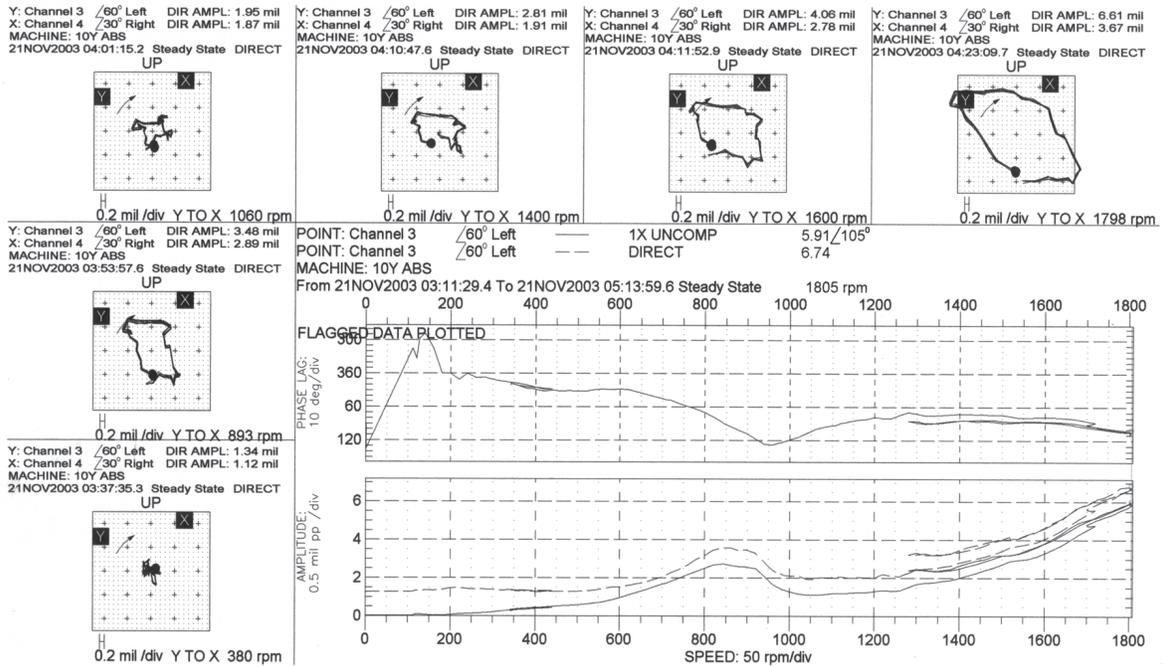
**Figure 1b: Bode Plots Bearing 10Y**

Coming out of the 1st critical, “vibrations” are not resolved, but remain at 0.001” (1.0 mil) because of the existing eccentricity, which causes an additional excitation of the 2nd critical (rocking mode).

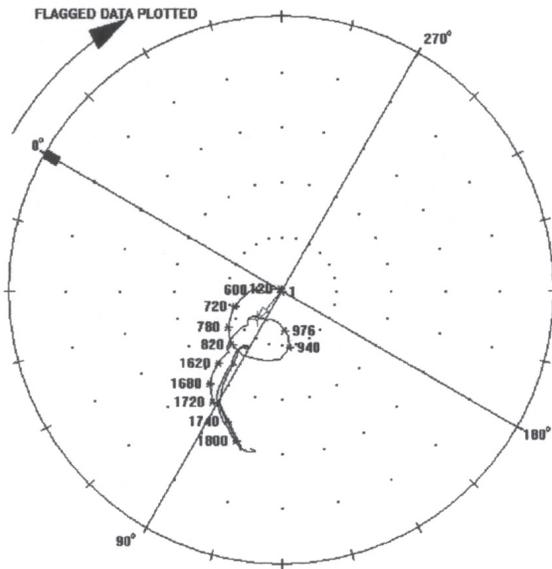
Figure 1c: Polar Plot Bearing 10Y– Absolute

It is important to know that some OEMs design their bearing assemblies with liberal side to side and top clearances. This feature in itself is not significant, but it allows for bearing “rocking” when sufficiently excited by shaft displacement. Shaft measured displacement may indicate elastic deformation of the rotor, eccentricity “whirling” at higher speeds, or “wobbling” at lower speeds due to bearing looseness. The effect of loose bearing is indicated by very different vector pattern seen on Polar plots for “shaft absolute” and “shaft relative” vibration signals. (Fig. 1c, 1d).

Based on all information so far, it was determined that some eccentricity exists on the rotor, large enough to cause the observed vibration symptoms.

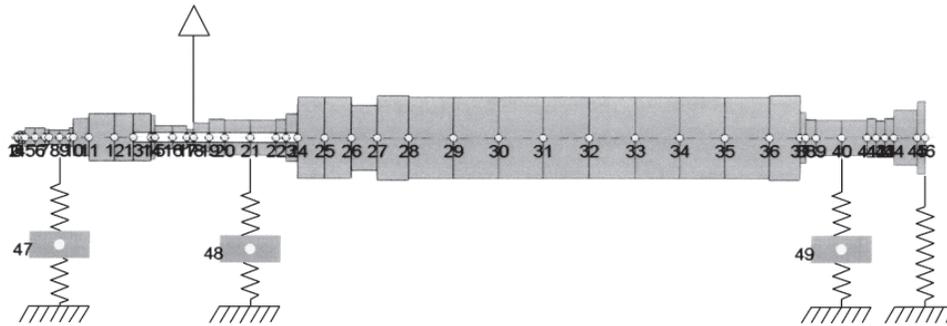
Figure 2: Generator Rotor Model with Simulated Weight

The generator rotor was modeled using DYROBES<sup>®</sup>, a FE software. The purpose of using a FE model was to save the cost for physical testing. Verification of the model validity was done by calculating rotor sag and critical speeds. (Fig. 2-5)

After verification, a simulation of the unbalance response was done. A simulated shot of 100 oz. was placed in the model at the GEN-EXC coupling i.e., at location where operators were placing the “balance

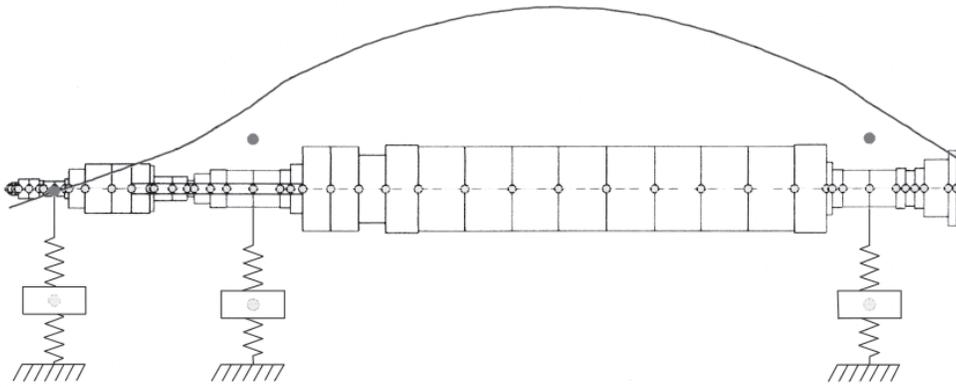
**Figure 4: Generator Rotor Model- First Mode at 924 rpm**

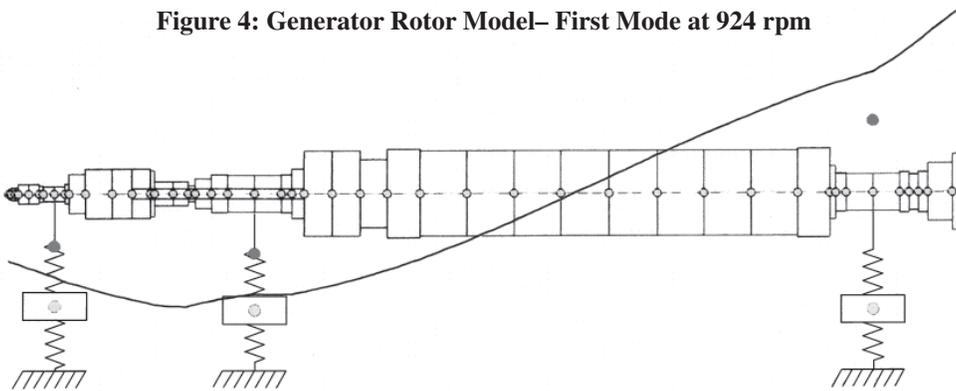
**Figure 5: Generator Rotor Model- Second Mode at 1933 rpm**

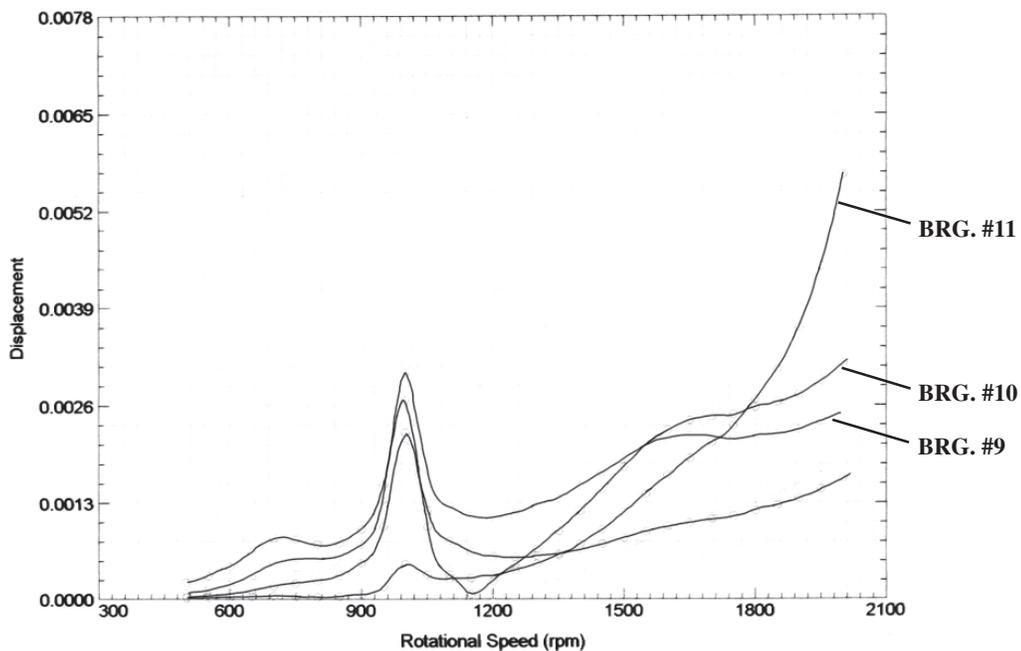
shot”. The model confirmed “improvement” of ~ 0.001” (1.0 mil) at bearing #10, but worsened substantially the response at the exciter bearing #11, exactly as it was occurring during the actual balancing. This seems to be in agreement with the past history of “balancing”. It also shows that field balancing is not a recommended procedure to solve current rotor vibration problems. (Fig. 6-7).

**Figure 6: “Normal” Responses, as Found**

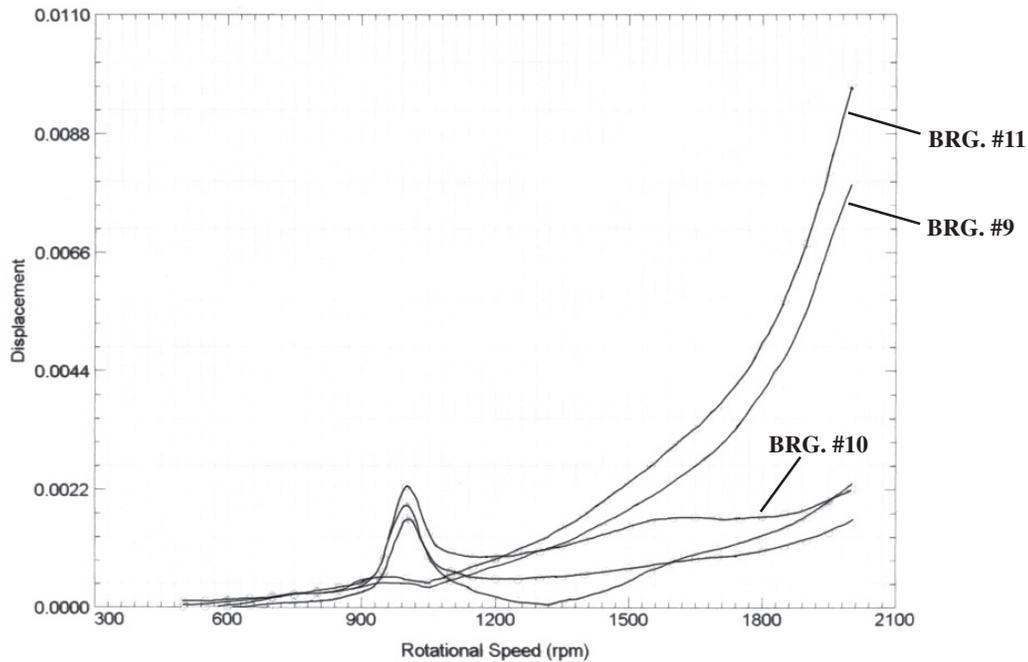
**Figure 7: Responses with a Simulated Shot at GEN-EXC Coupling, Approximately 100 oz.**

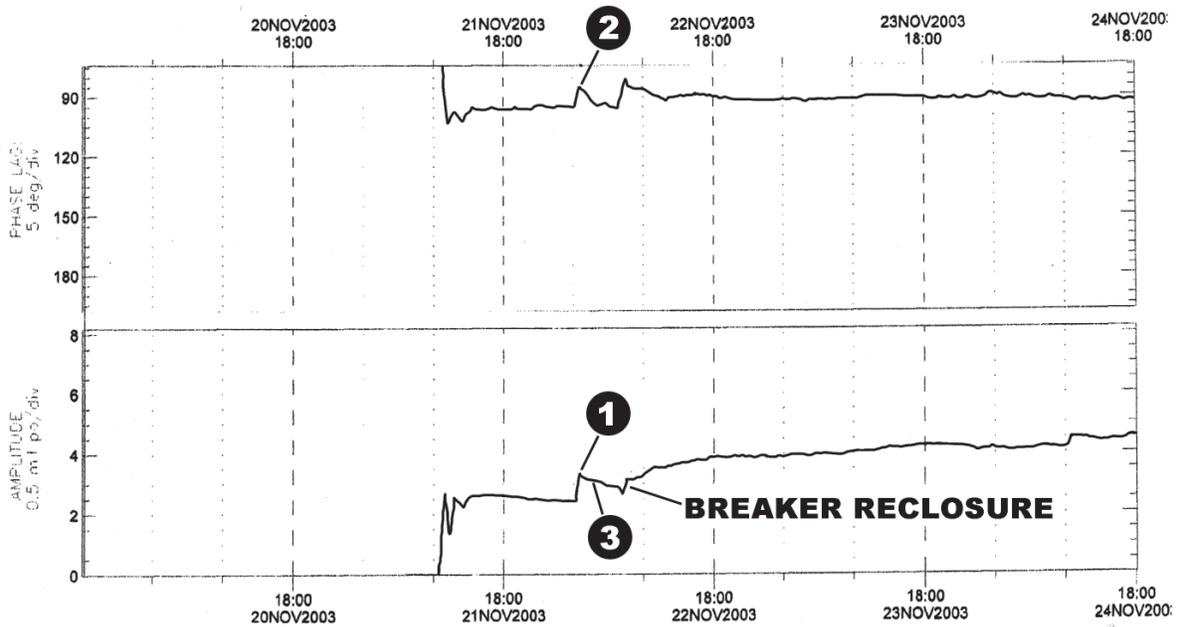
**Figure 8: Time Response Plot**

At the moment of field excitation, the rotor was spinning at 1800 RPM. When the exciter breakers closed, a magnetic field was created in the air gap which “shocked” and excited the rotor’s running mode. The shock was evident by instantaneous amplitude rise and the phase reversal. (See points 1 and 2 respectively on Fig. 8)

The generator was synchronized shortly thereafter (approximately after nine minutes). As the rotor continued to be heated from the applied current, a small “thermal” vector was developing. This vector alone cannot be observed, but only as a vectorial sum change of the initial unbalance vector and thermal vector itself. This is marked as point 3 on Fig. 2.

The upward vibration spike visible at journals #10 and #11 is caused by the unequal circumferential distribution of the strength (hence the radial force) of the magnetic field at the moment of closing the field breakers. This force is longitudinally equally distributed along the length of the rotor coils. This force, since it acts along the rotor, is exciting the rotor’s first mode. The angular location of this magnetic field differential force is exactly opposite the existing shorted turn.

Since the 1st mode (static unbalance) is superimposed over the operating deflection mode (second mode or couple unbalance), it is logical that one side will show an increase and the other side a decrease in shaft vibration amplitude. This additional vibration rise happened to be in addition to the mechanical eccentricity detected at generator exciter end (EE) side. The new, sum vector (eccentricity plus differential force from the magnetic field) rotates at synchronous speed and acts as increased unbalance.
