Proactive Shop Strategy to ensure a smooth post-outage startup without field balancing

**EPRI 2020 Winter TGUG
Steam Turbine Workshop
Amelia Island, FL
January 14, 2020**

Case Studies

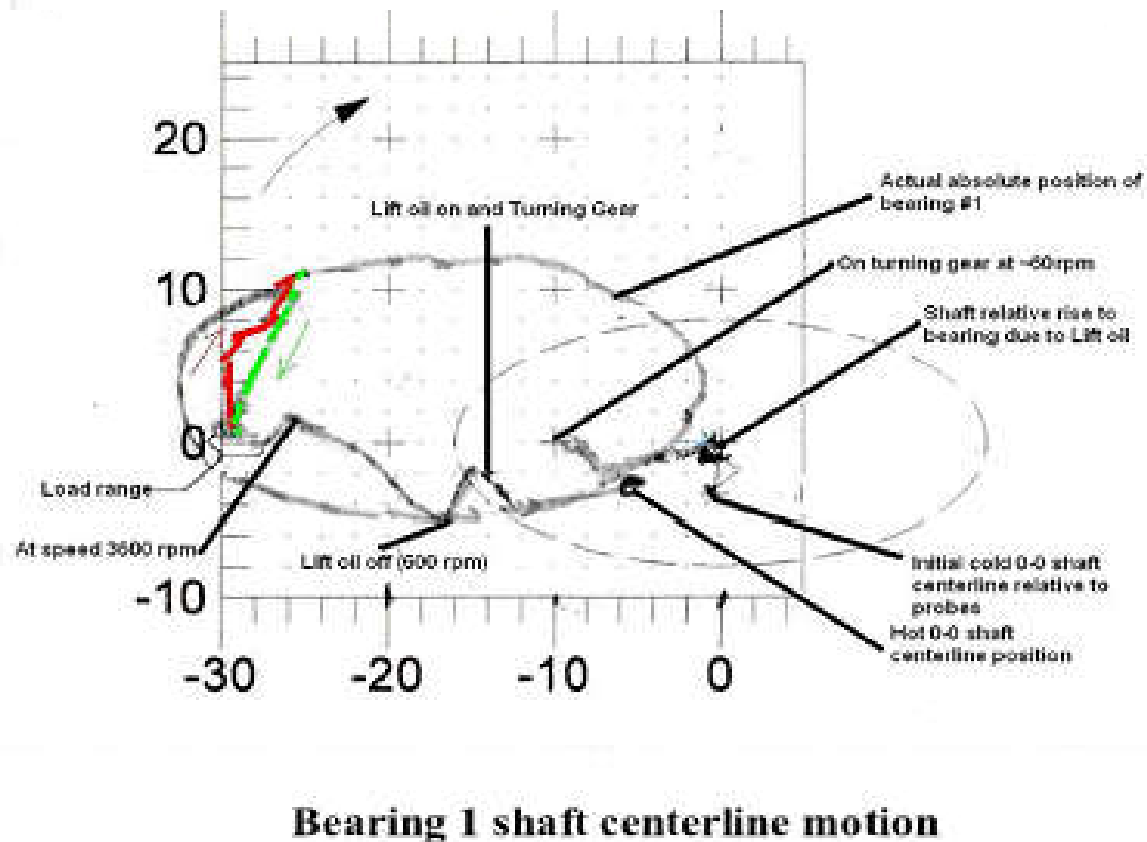
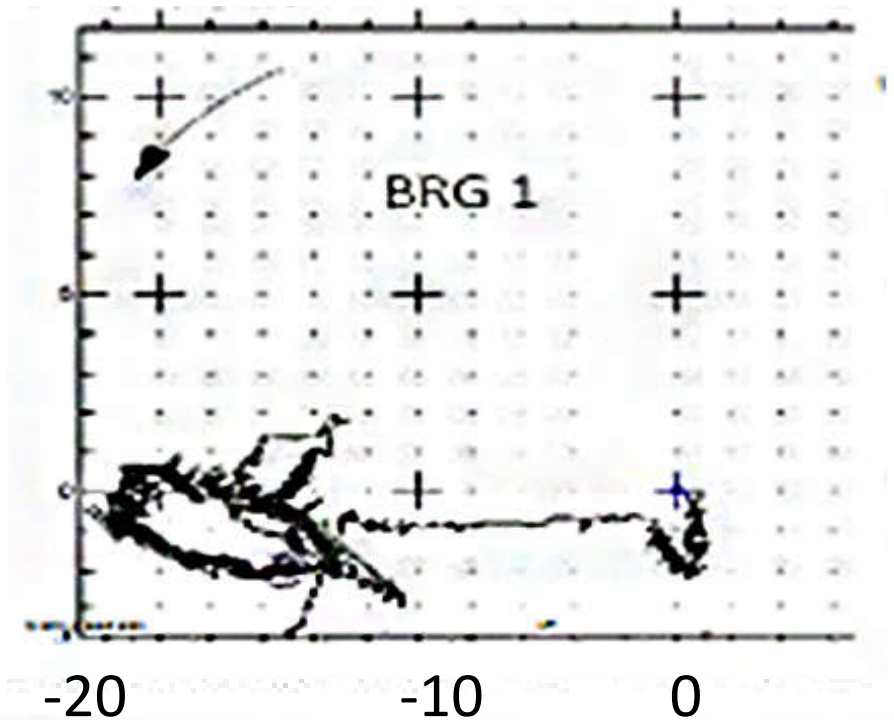
Superimposed
Brg #1 orbit: 2 mils/division

- Shaft centerline motion of HP front journal showed 15 mil horizontal move from standstill to 600rpm, plus 15 mils more going to load

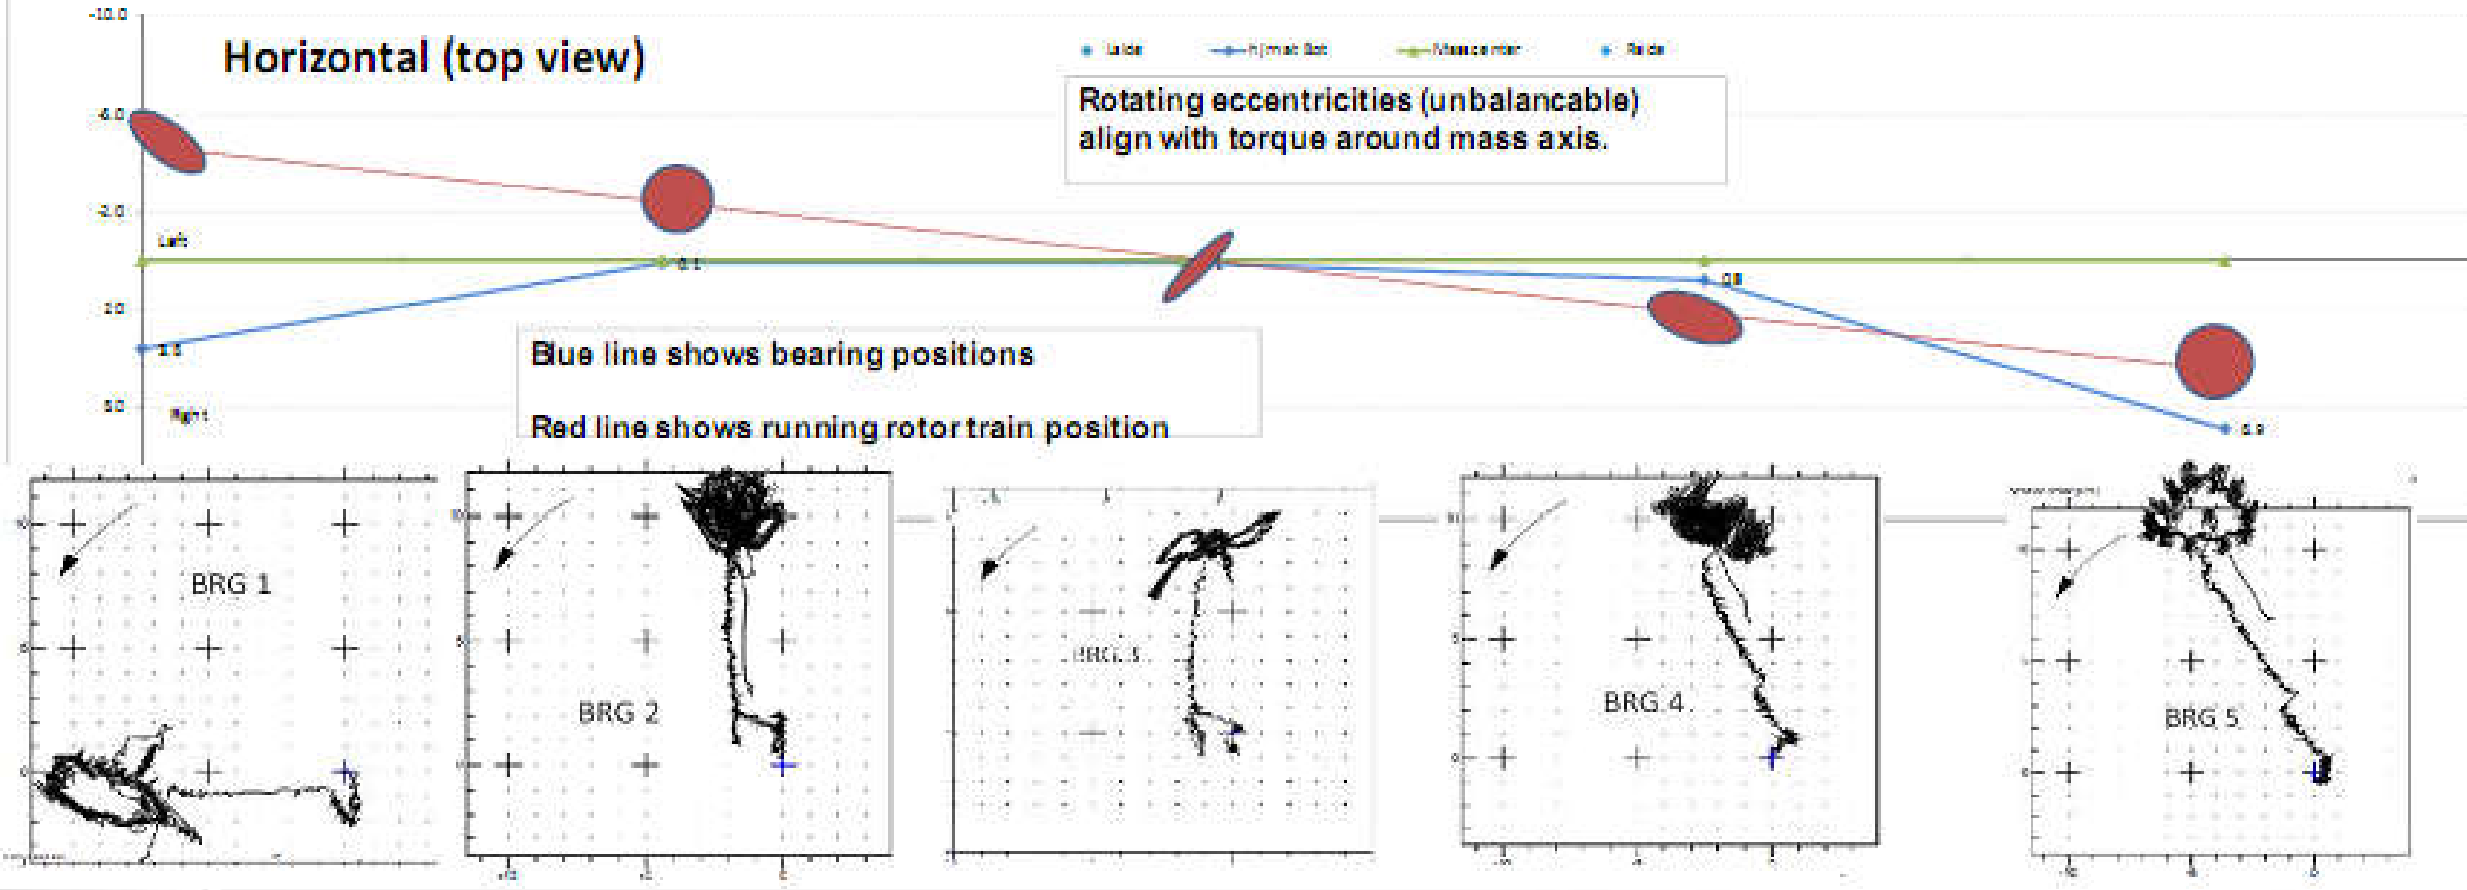
(Shaft Orbits superimposed onto shaft centerline plots)

- The inertia driven self-straightening of the heavier Generator + LP rotors pushed the lighter HP rotor horizontally until hitting its constraint point at bearing #1

- FE modeling determined the side forces from misalignment were 30,000 lbs on bearing #1 from the HP rotor “spring”, plus expected gravity load
- Resulting bearing load exceeded the compressive strength of the babbitt
- Additionally, the bearings had used replacement cheaper babbitt with less load capacity than OEM specs
- The solution:
 - Repair the bearing with stronger, OEM babbitt material
 - Move the HP front bearing 20 mils to the left (the maximum attainable), with recommendation for LP-generator alignment within a year’s time
- The unit was operated for 5 years in this state, until the generator developed a ground fault, and full realignment was completed, with no problems since.

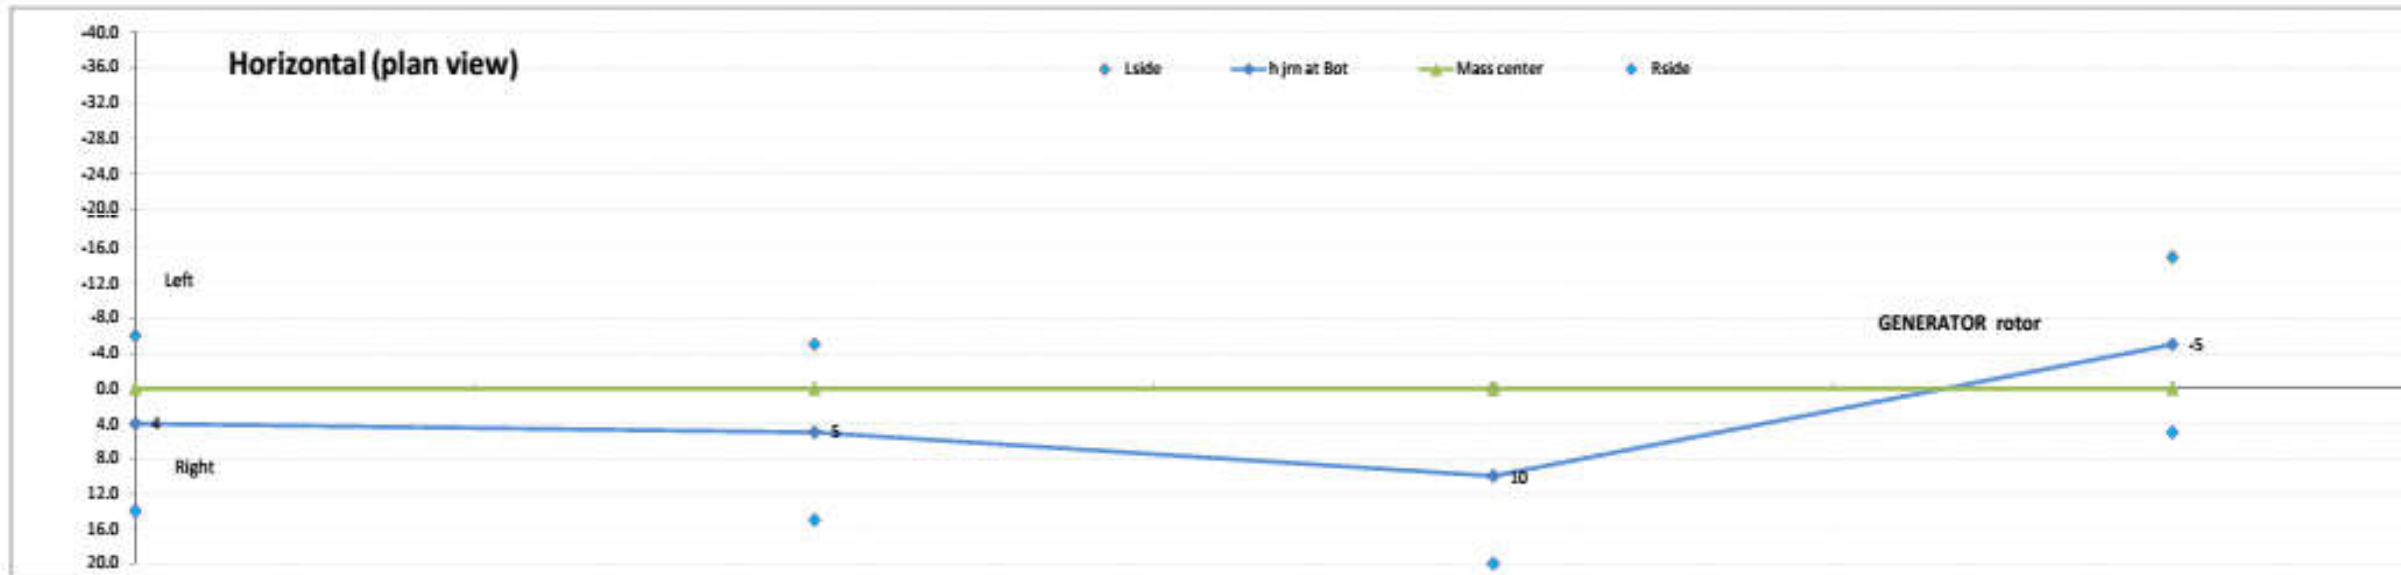
- OEM focus had been on subsynchronous vibration component, and tried several generator bearing modifications without success
- Our analysis, tracking the DC shaft centerline position from standstill gaps, to gear, through the speed range and load range, found horizontal misalignment between the LP and generator rotors

- Recommended to correct the generator to LP misalignment to eliminate the driving force
- However, the plant did not want to correct misalignment, and instead continued operating at reduced load, until a short time thereafter, the generator rotor developed a ground fault and had to be replaced, and then was finally realigned

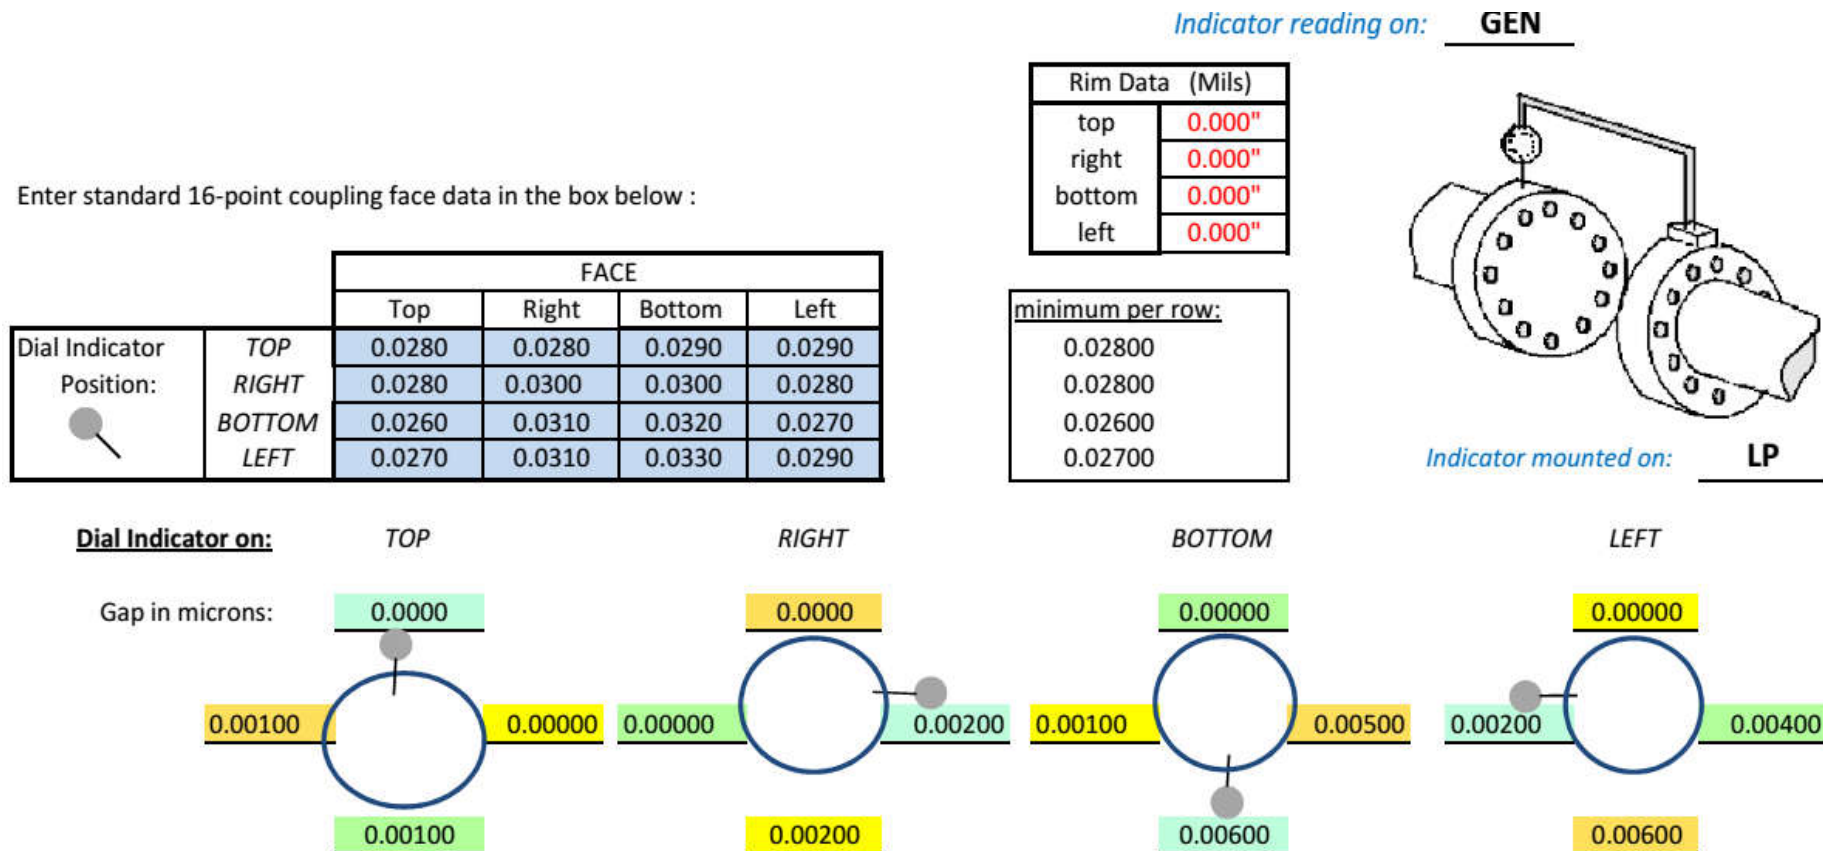
16-point field alignment data further confirmed misalignment and unresolved off-square coupling faces, despite gaps being within “specs” when averaging the measurements

Face readings: If gap remains on the bottom across all cases, couplings are likely ok, and bearings are not exactly aligned (some preload)
 If gap rotates around, then the couplings are off square

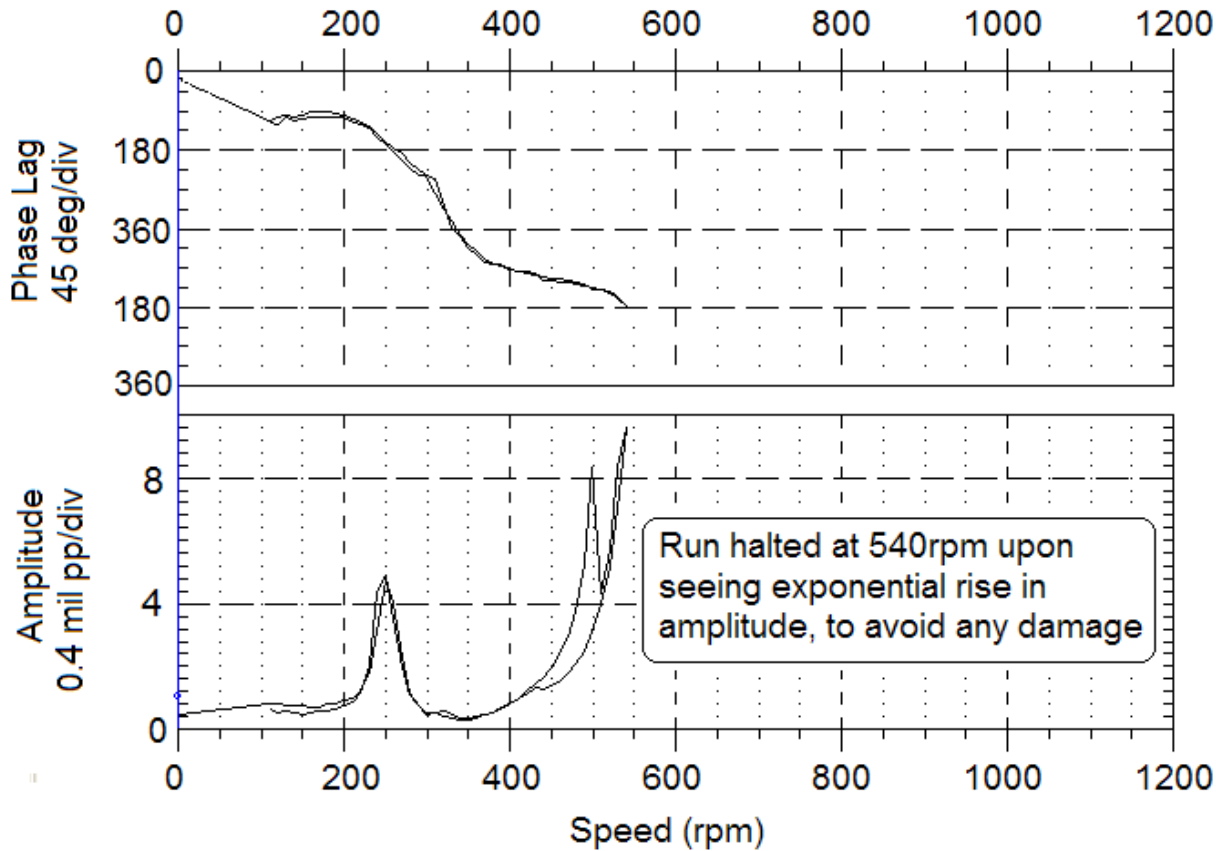
First Attempted Roll Without Balancing Weights

- The first step of analysis was to mathematically evaluate the most recent shop TIR data
- The rotor body forging showed **1x eccentricity of ~0.004”**. It was also revealed that the generator TE side overhang was bowed, and coupling rim was eccentric by ~ 0.004”.
- We suspected the rotor’s “sensitivity” was actually mechanical in nature, proportional to torque/load, due to driving the bowed rotor and bowed overhang
- We recommended:
 - Machine coupling face to less than 0.001” perpendicular to TE side journal
 - Machine a reference band on coupling rim to less than 0.001” TIR to journal
 - Balance the rotor at 1st critical speed using the Quasi-High Speed Balancing method in three simultaneous balancing planes

- After machining was completed, initial balancing was first tried by a shop balancing engineer using “industry standard” modal balancing.
- The balancer spent **over forty runs** without a solution, struggling with compromise between “static” and “couple” balancing
- Either first critical response was high, or running speed vibration was high
- Balancer requested assistance, and the QHSB method was used
- **Solution at 1st critical speed was found by distributing the initial amount of the balance correction weights in three planes; 50% in the mid-plane, and 25% in each ¼ planes, to better axially mirror the eccentricity distribution.**
- Rotor balancing at the 1st critical speed, at second critical speed, at operating speed and overspeed, and electrical “heat run” at rated excitation current was completed in **nine runs**.

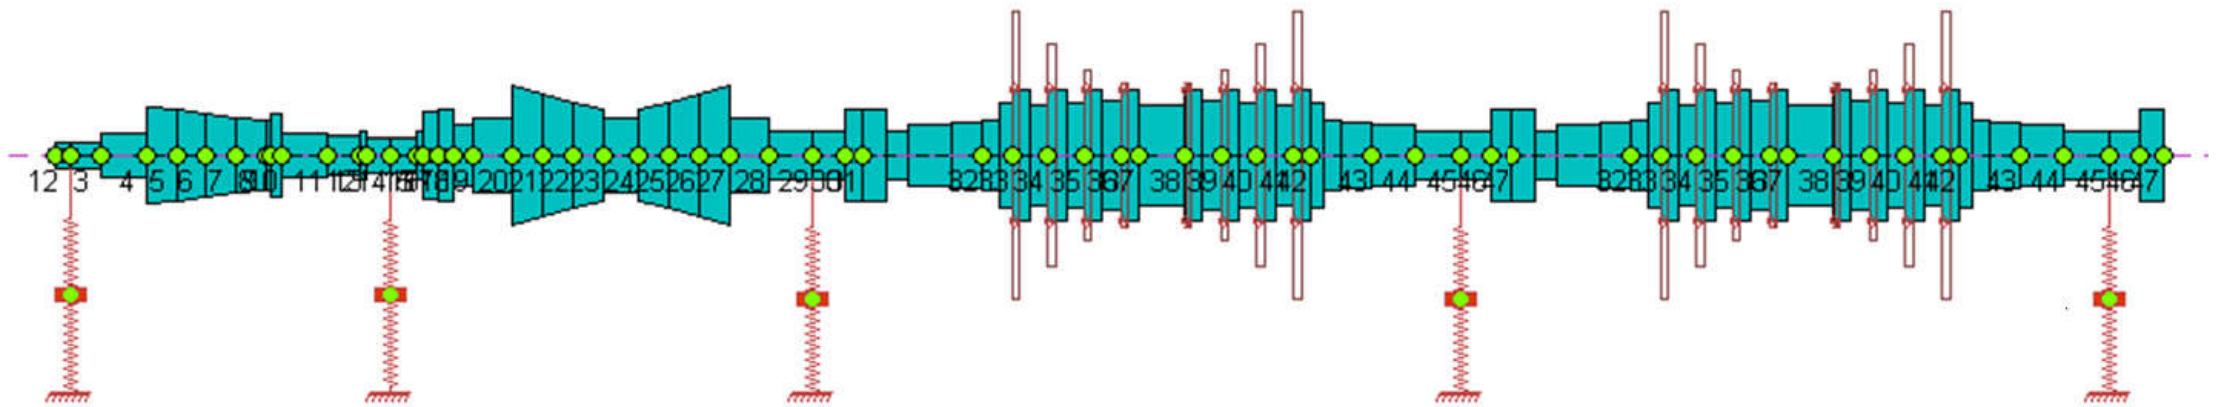
- After turbine-generator up-rating by nearly 100MW, vibrations at HP #1 bearing journal were increasing up to 0.012" (p-p) in operation proportional to load.
- Client attempted to reduce vibration by balancing the HP rotor, and had tried several contractors, but without any visible success.

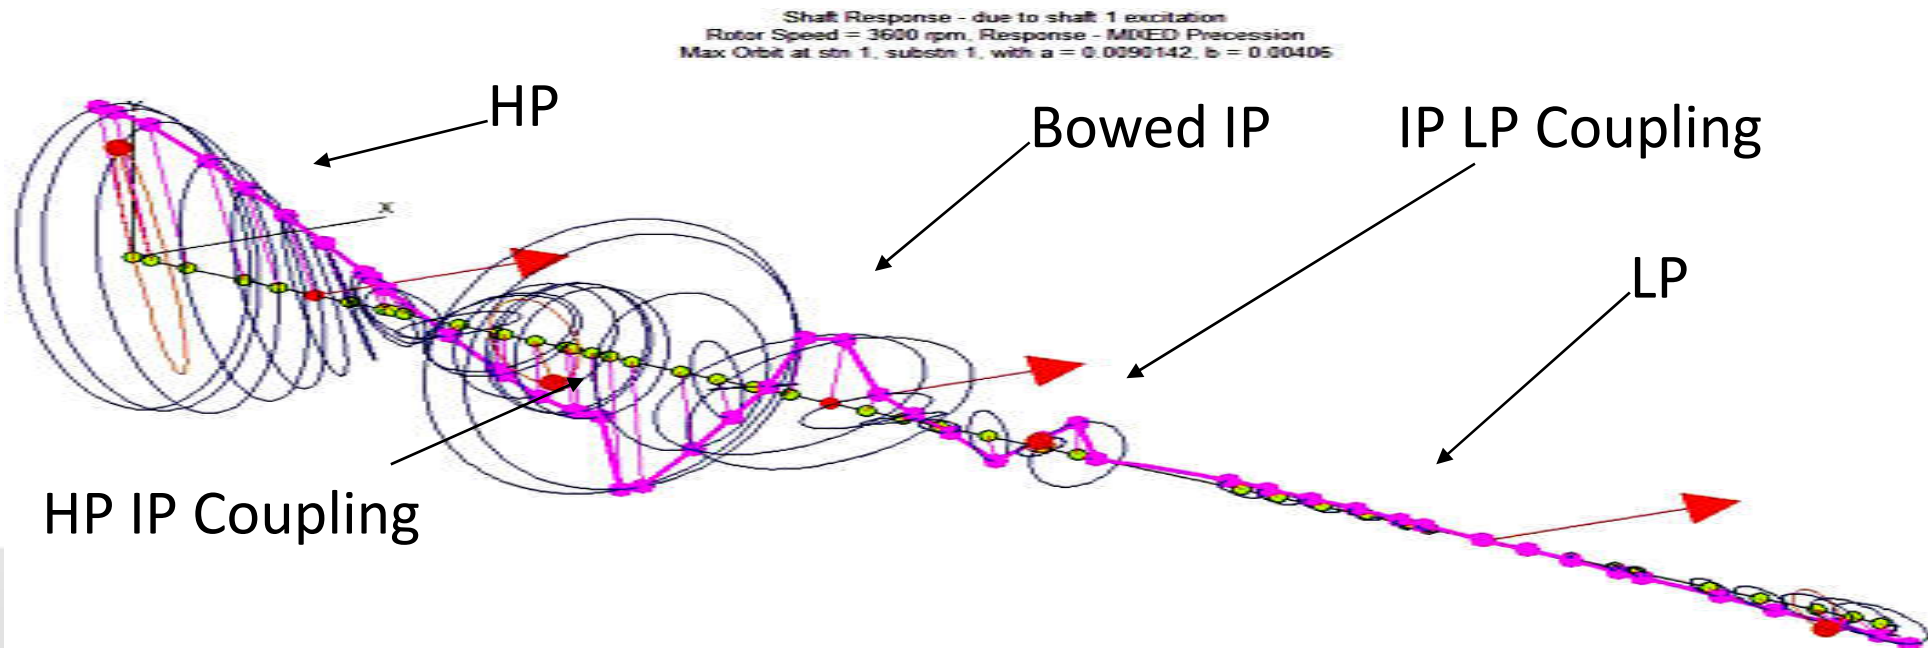
- The mass axis of the rotor with the largest inertia self-centers, and all other rotor mass axes tend to self-align to this common centroidal axis. The lighter rotor (HP turbine) with eccentric masses relative to the common centroidal axis then whirls synchronously within bearing clearances.
- The bowed, shop-balanced IP produces high motion on the adjacent, perfectly balanced HP rotor due to coupling eccentricity and out of perpendicularity.

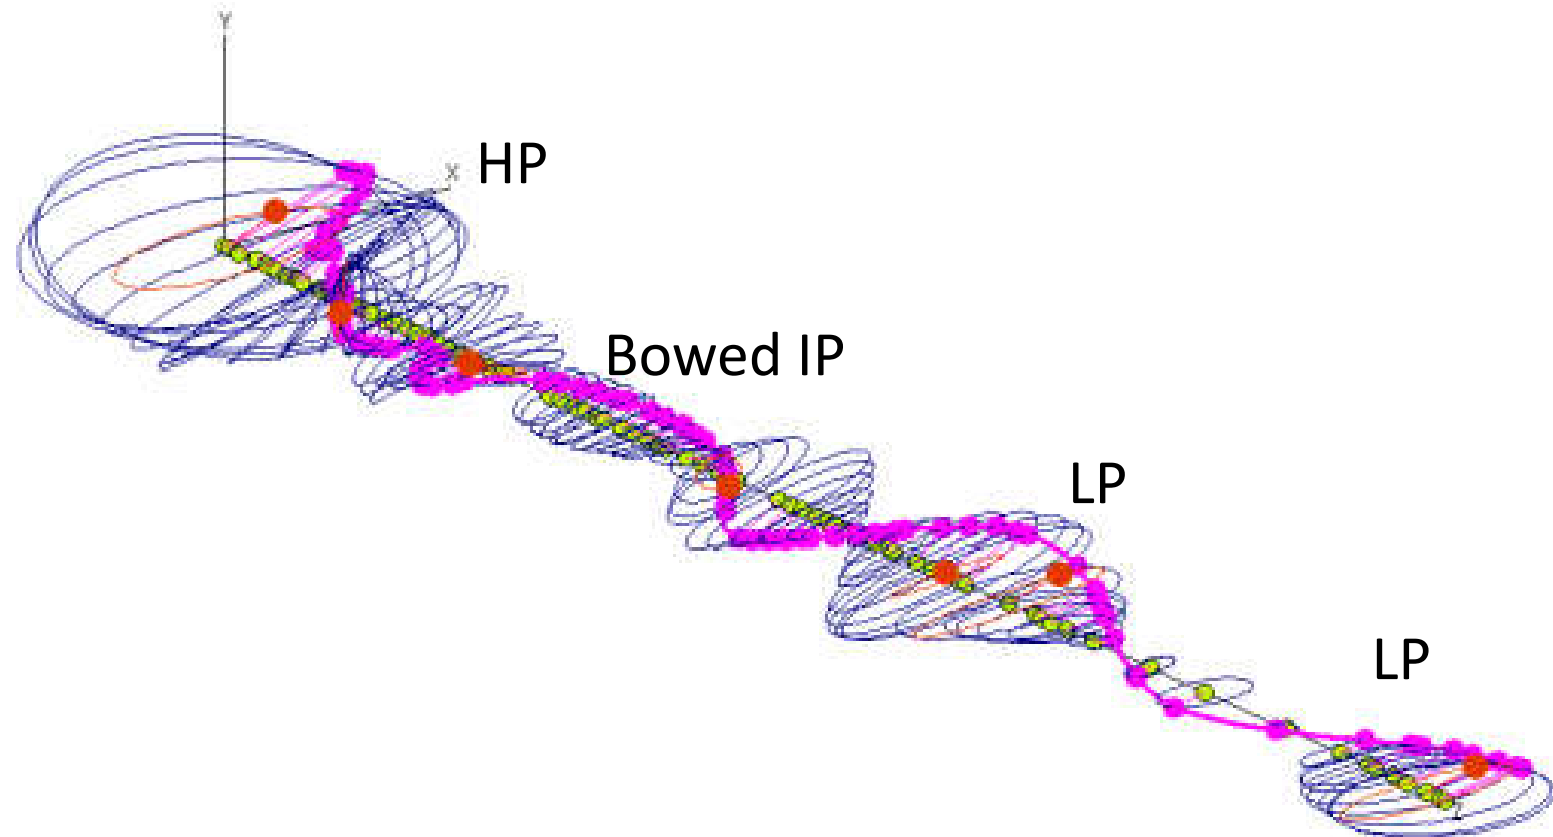
- As long as whirling is not constrained, sensors will indicate large displacement from kinetic energy, but relatively low seismic vibrations.
- The unit was allowed to continue operating in this condition for over a year, until a planned outage scheduled for removal of the IP rotor for machining correction and rebalancing.

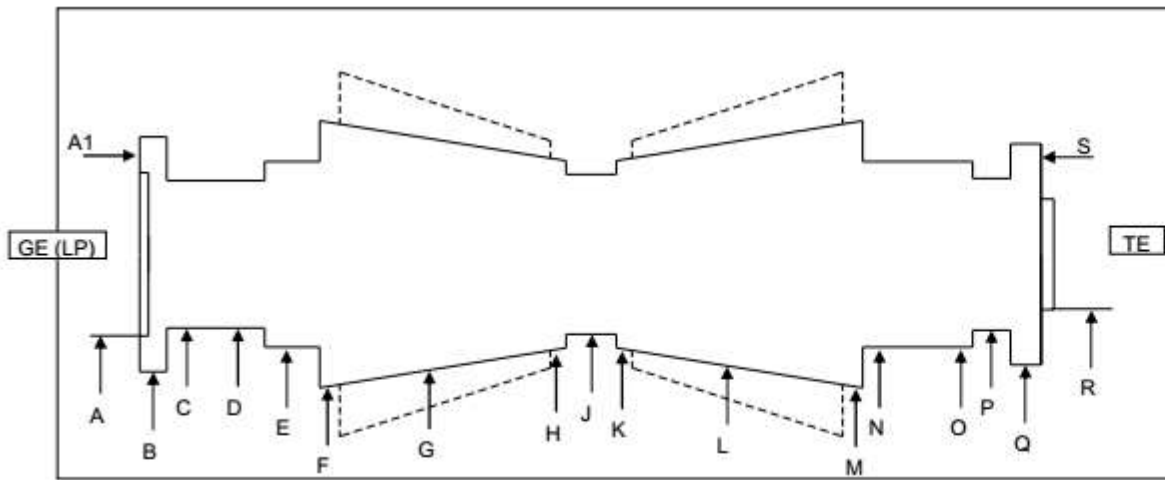
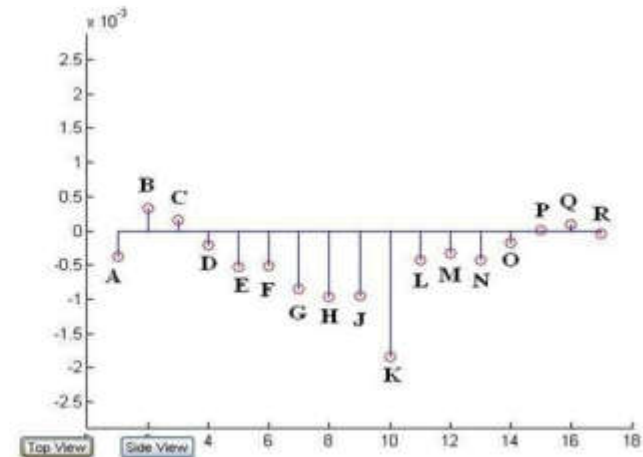
- TIR evaluation of the IP rotor showed up to $\sim 0.002''$ 1x eccentricity (~ 4 mil TIR) on the rotor body, plus ~ 3 mils on the HP coupling face – this skewed the HP rotor in operation

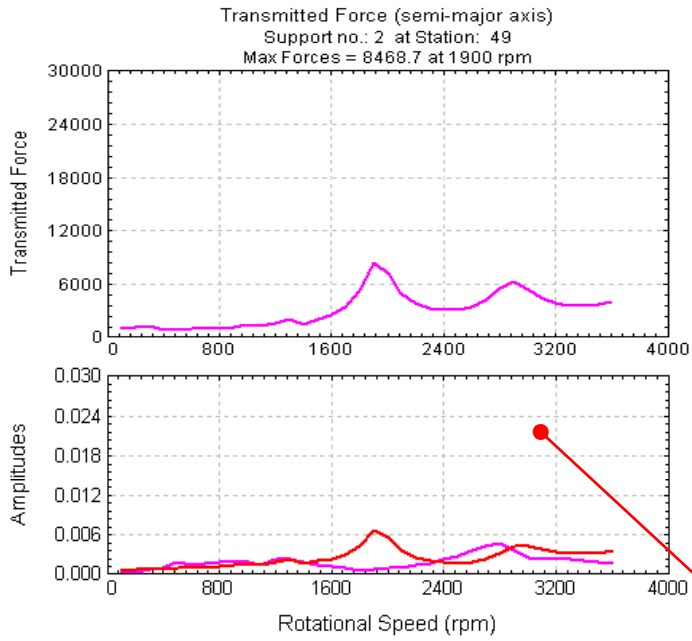
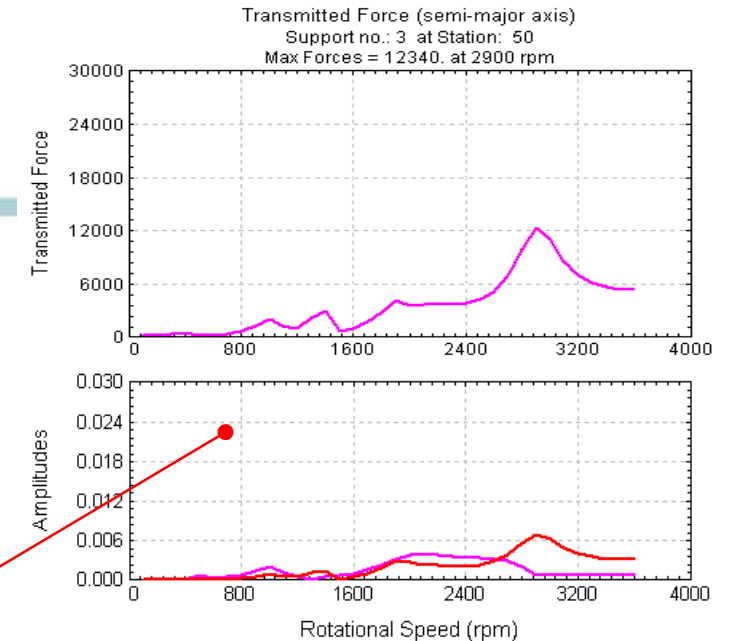
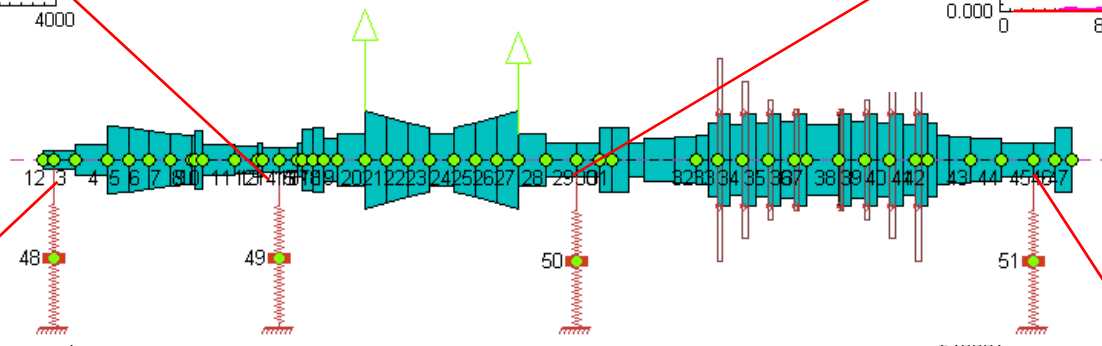
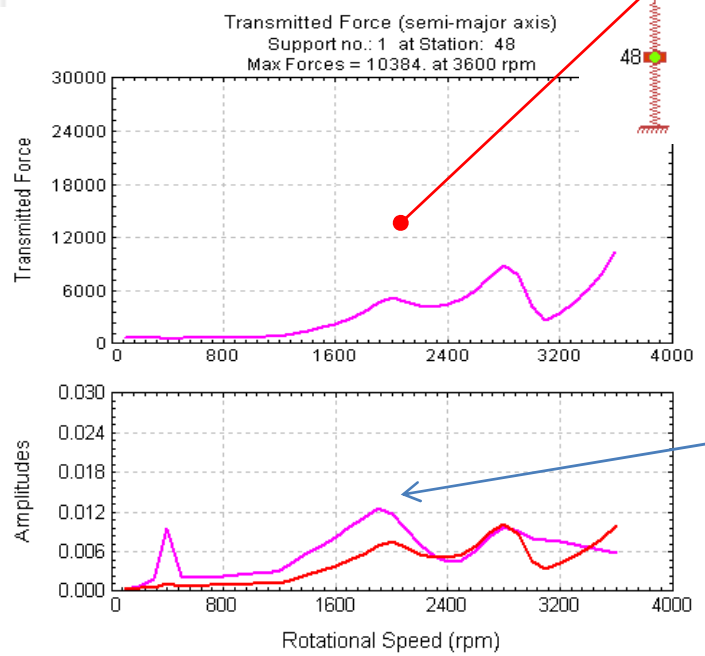
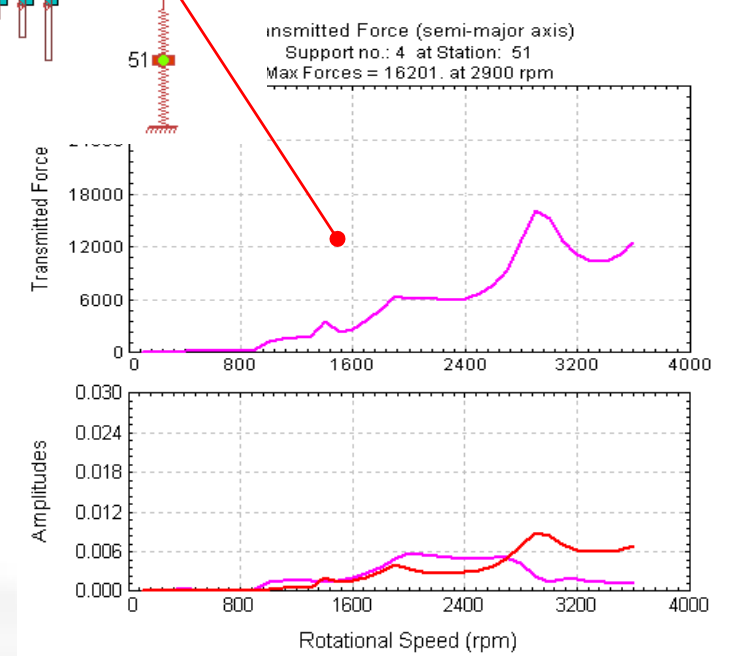
Bowed IP balanced
using only 2 endplanes

Amplitude at HP front
up to 12 mils
