Diagnosis and Solution of the Exciter Rotor Vibration Problem

Zlatan Racic Baodong Sun, Ph.D.

This paper addresses the experimental and theoretical investigation of unacceptable high vibration during startup and coastdowns on the #7 exciter bearing of a 384 MW unit. The Encina Unit #5 Turbine Generator has had the vibration problem since the unit became operational in 1978. The high vibration occurs during startup and coastdowns at 2500 RPM, which is the first critical speed of the exciter and the second critical speed of the generator. Shaft vibration occurs during cold starts had been in excess of 25 mils (peak to peak). Numerous balances on the exciter were attempted over the years, as well as several on the generator, to correct the problem. Vibration amplitudes were optimized, but the problem was not solved. Vibration data showed that the #7 bearing is very lightly loaded. A detailed theoretical analysis of the rotor-bearing system indicated that static bending stresses at the generator-exciter coupling are "zero" under current alignment and the exciter vibration problem is the result of a compromised alignment, possibly done to resolve the generator instability problem in t

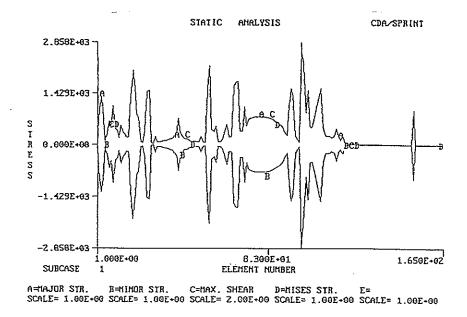
Fig. 3 Static Deflection and Stress Distribution with Current (existing) Alignment Line

From the calculated results, an interesting observation was made when looking at stress distribution plots (Fig. 3). While current alignment-line did what it is supposed to do with generator operation, static bending stresses at the generator/exciter coupling was "zero"; however, some stresses were introduced when the unit operates and the exciter journal was running in upper bearing quadrant (Fig. 1), moreover, the current alignment caused high stresses over 5,911 lb/in² in the generator as shown in Fig. 3; in case III (Fig. 4), the #7 bearing reaction are improved and the stresses are reduced below the case II. The maximum stress is reduced from 5,911 lb/in² to 2,850 lb/in². In order to check the accuracy of the calculated static deflection, the sum of the bearing reactions must equal the gravitational load of turbine-generator. In Table 2, it is seen that the total bearing loads are in very close agreement to each other.

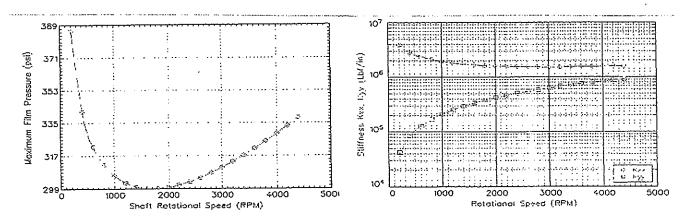
Fig. 5 Maximum Film Pressure vs. Speed

The hydrodynamics characteristic of the exciter bearing was computed. The exciter #7 bearing was a 4 tilting pads bearing. Through an analysis of the bearing, with clearances as currently installed, pressure distribution (Fig. 5.) over the speed range indicates a drop, exactly in the region of the exciter rotor resonance's 1860-2484 RPM.

- (2) Bearing Re-design
- A Four pad tilting bearing #7 of the exciter will be better replaced with the five pad tilting bearing with load on the bottom pad, installation clearance of approximately 0.8 mils/inch of diameter, and preload of 40-50%.
- B Reduce clearances of the existing bearing and assure there is 40% preload on the pads. The choice between A and B is purely of economic nature. Bearing characteristic are almost identical. The only difference is with consideration to alignment, since A bearing has 5 pads with load on the pad and bearing B has 4 pads with load between the pads, and rotor sinking between the pads, with four pad bearing must be taken into account.
 - C In either case verify, and machine as necessary the bearing fit, and check good anchoring of the pedestal.
