Runout Measurements with Non-Contact Probes, and FE Modeling, Tools in Root Cause Analysis (II)

Zlatan Racic

Z-R Consulting • Bradenton, FL

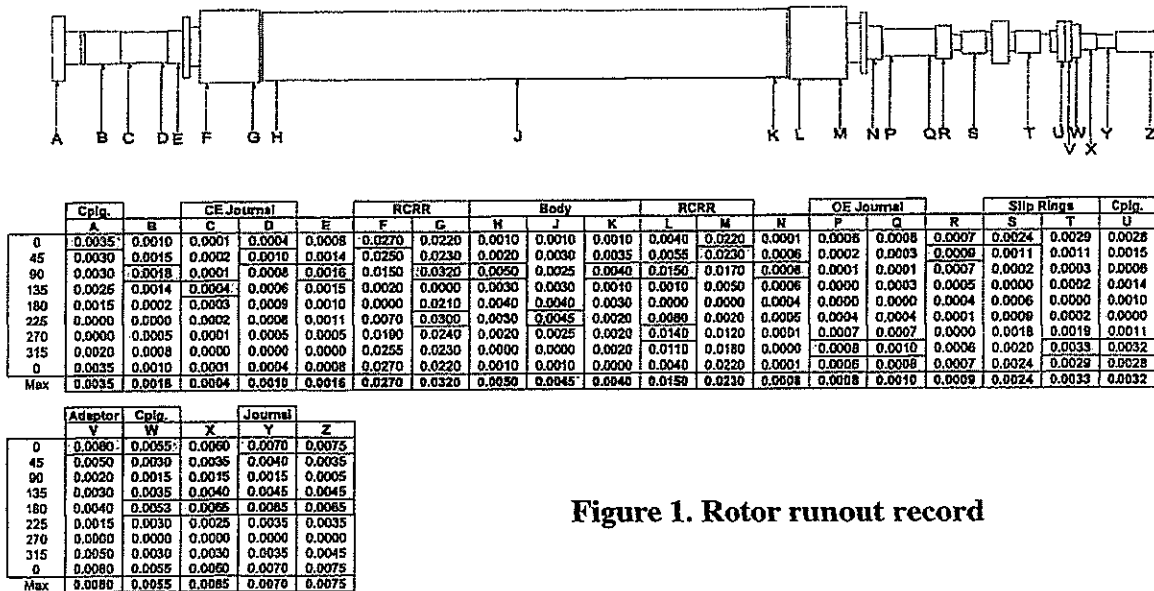
Figure 1. Rotor runout record

Runout data on the rotor had revealed that the rotor body was eccentric to journals by about 0.004–0.005” (Fig. 1). This had prepared the balancer to anticipate a relatively large amount of balance correction of the first critical speed. This also gave a hint that the journals on this rotor had been re-machined at some point in the past.

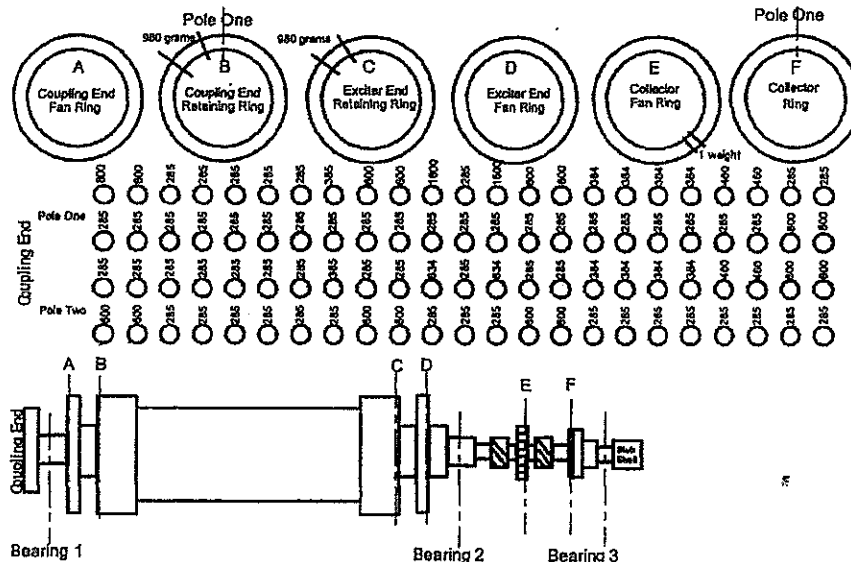
Figure 2. Rotor balance weight map

Also found was an indication of a “kink” on the CE side of the rotor shaft of about 0.0035”. This “high spot” was also in line with the rotor body eccentricity high spot (Fig. 2). These findings were conveyed to the owner’s observer during the balancing process in the Bunker. Both observations are not typically detrimental to the balancing process in the Bunker, but the observer was made aware of possible problems during the alignment and operation in the plant.

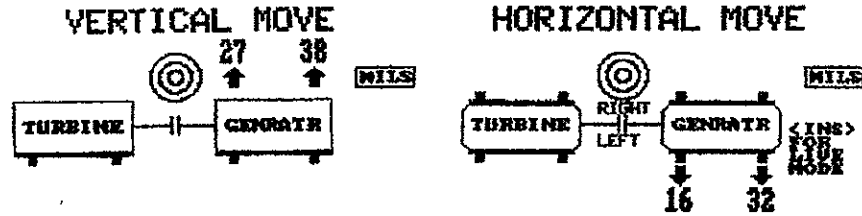
Figure 13. Laser alignment data

After reviewing the rotor runout data and noting a possible alignment problem due to a “kink” in the rotor, it was recommended to verify current alignment. Laser equipment was utilized, and final data had indicated that the stator has to be moved to bring the generator bearings in line with the LPB bearing (Fig. 13). The move was not performed because of a jammed coupling bolt, which could not be immediately removed.

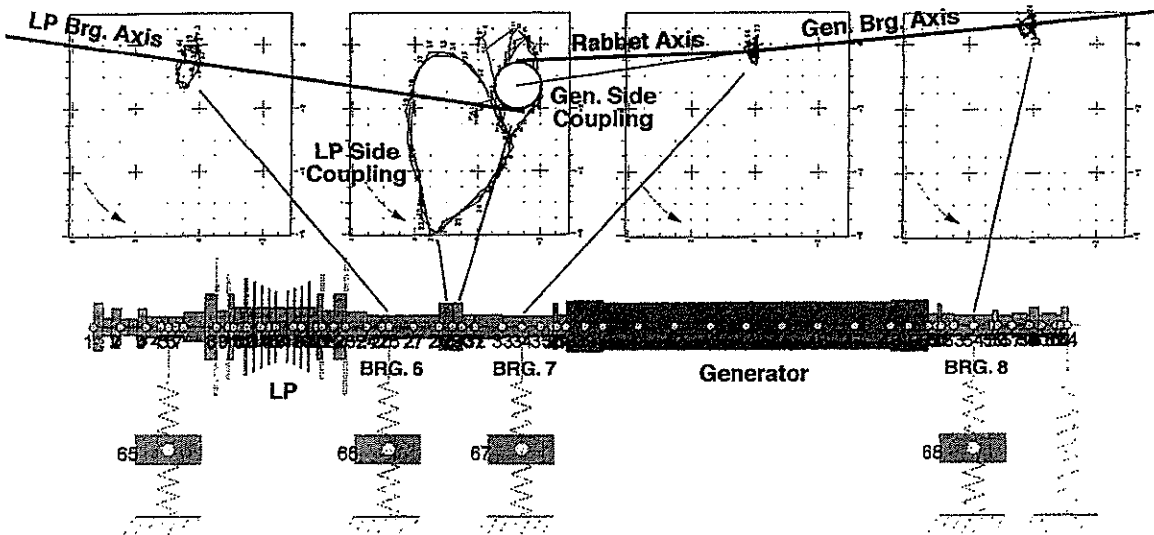
Figure 14. Bearings centerline offsets and local runouts

Another verification of bearings alignment was done utilizing temporarily installed pairs of proximity probes at bearings #6, #7, #8 and LPB-Gen coupling. These readings (plots) had confirmed the laser readings about a required stator move (Fig. 14).

Despite the need for alignment, the magnitude of the move could not have been the sole cause of the encountered vibrations.

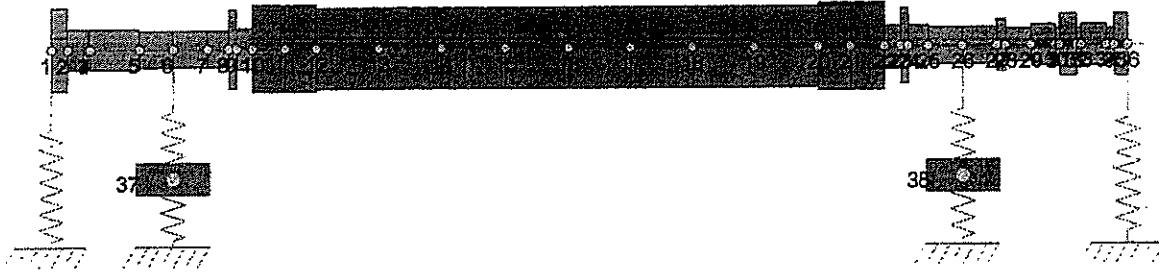
Figure 20. Modeling-- generator shaft journals eccentricity at both bearings

The original model was retained with changes added to the support system for better simulation of the actual site conditions. At both ends of the rotor, a “spring” was added to simulate the effect of LPB and exciter shafts. Bearing stiffness, damping and pedestal masses were tuned to obtain critical speeds observed at the plant. Eccentricities at journals were reintroduced after a suspicion that the original rabbet was not concentric with the re-machined jour-

nals. This can be supported with the facts that the original bolt holes centerline was retained and the original coupling bolts were still being used.

The eccentricities were needed to be introduced in the model as the only excitation driver to produce simulated amplitudes and a whirl mode to match the actual ones. This model had shown that due to coupling eccentricity to generator journals, a “dynamic” unbalance response and a corresponding whirl mode would not allow successful balancing at all speeds, i.e., at criticals and at operating speed using only two balancing planes. The original unbalance response and two field balancing attempts were simulated. (Figs. 20–24).

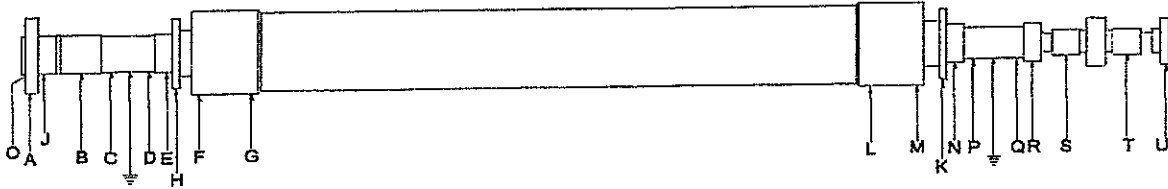
Figure 32. Readings with rotor running on journals by OEM

the plant were evaluated. These readings include TE coupling rabbet but still no indication of the coupling face perpendicularity. The most important readings show the total eccentricity between TE coupling rabbet and TE journal (Brg. #7), of 0.003". Other eccentricities in relation to a common center are printed. (Figs. 32-34).

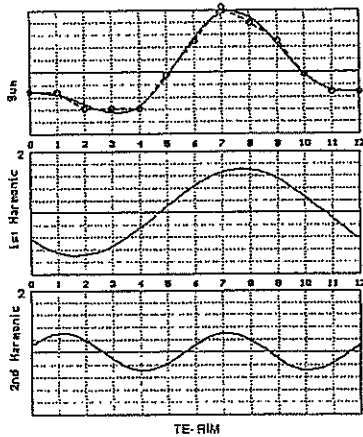
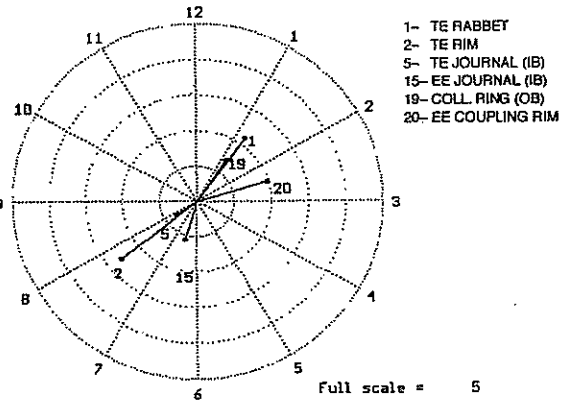
Figure 34. Shaft run out diagram

Shaft Run Out = 3
High Spot Position = 7,7
2nd Harmonic = 1

The method of the runout evaluation consists of data plotting, smoothing the time curve and then performing an FFT analysis. This method then separates the first harmonic (eccentricities with a reference to the origin of coordinate system as "Zero", and a second harmonic, which is so prevalent on asymmetric rotors, like a two pole generator. The graphical presentation of the analysis results helps visualize the relative relation of the eccentricities, between the critical elements: coupling rim and rabbet fit, used for the alignment, and the journals, which axis represent the axis of rotation.

After considering the alternatives, it was recommended by the author to remove the rotor, carefully examine eccentricities and re-machine the rotor to the original specifications and tolerances.

Another alternative would have been to just correct for a "kink". That would require bringing the coupling rim, rabbet (spigot) and bolt holes centerline concentric with journals. Coupling face, back face and bolt holes would have to be brought perpendicular and parallel to the journals.
