# **Vibration Measurements and FE Modeling Tools in Root Cause Analysis (I.)**

**Zlatan Racic**

Z-R Consulting

This paper covers a case history of a generator rotor which went through extensive repair and modifications. Despite a great effort in following the work processes and quality control in the shop and with successful completion of repairs and high speed balancing (solo) in the bunker, the rotor exhibited unusual behavior when installed in the field. Vibration of any machine is only a symptom which in a traditional approach is treated by “balancing”, very often without ever discovering the root cause of the vibration. Treating the vibration process as a symptom, and diagnosing it for its root cause, is the topic of this paper.

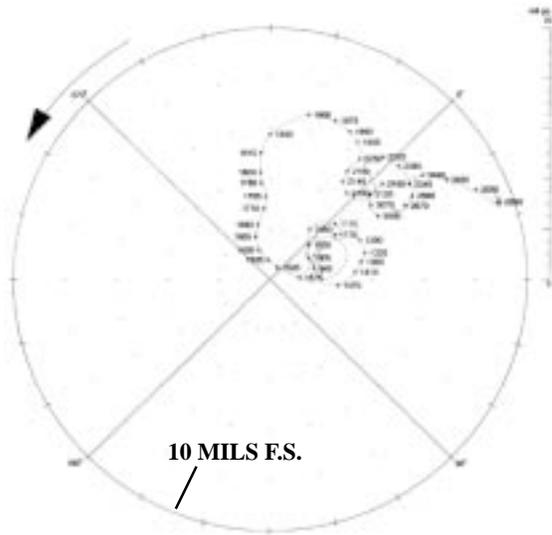
**Figure 1: Original Shut Down (GENFR)**

Since the start-up data was not available, the machine was shut down in order to record vibrations. Only Front Right and Rear Right shaft absolute vibration is presented here. (Figures 1 and 2). One can see that vectors are in phase since the rotor is operating practi-

cally on top of “third critical”. There are no 1st or 2nd criticals visible, which means that the rotor was mechanically well balanced.

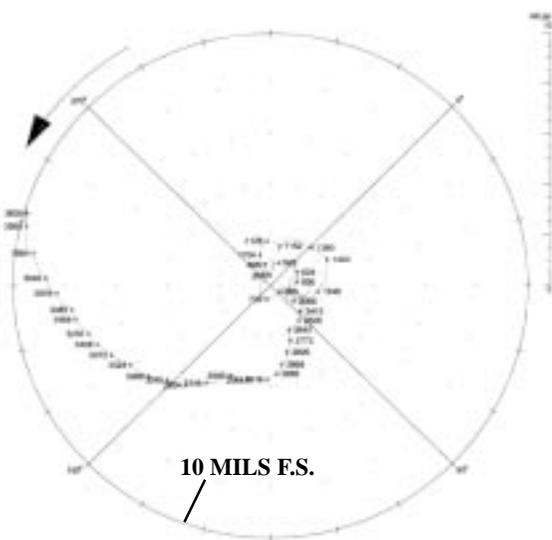
**Figure 3: Shut Down with First Trial Run- 760 gr. @ 180° st. (GENFR)**

The after balancing results were surprising because the total vector change was double than which was expected (Figures 3 and 4). Again, there is no evidence of 1st or 2nd critical response, and all the change (increase) in amplitudes occurs between 2500 to 3600 RPM.

If we consider that the response vector at 3600 load condition is purely “thermal” unbalance response and it is repeatable, then a trial run based on the historical sensitivity of the rotor would require ~800 gr. at each end of the rotor, i.e. a static weight placement affecting primarily the 3rd mode, i.e., operating speed deflection shape.

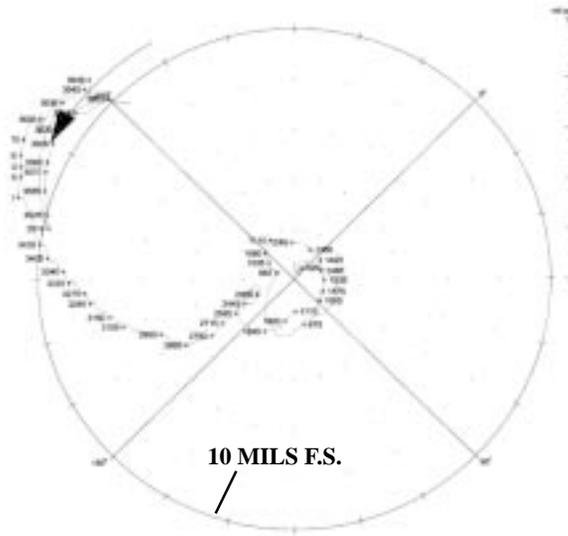
**Figure 5: Overspeed and Verification of "Critical" Peak (GENFR)**

For the sake of confirmation of the resonance at 3600 RPM, the speed of the rotor was increased to 3700 RPM prior to shutdown. Now it becomes evident that the 3rd critical peak is practically at 3600 RPM. (Figures 5 and 6).

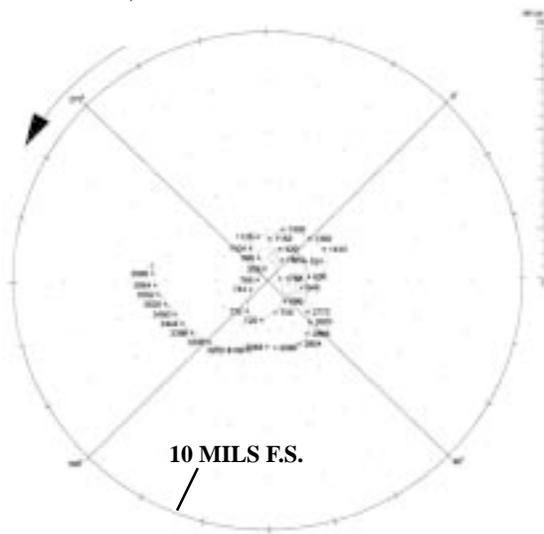
**Figure 7: Start Up with Reduced Weight (GENFR)**

The amount of weights were halved and we obtained the starting position for the "thermal" vector where we wanted (Figures 7 and 8).

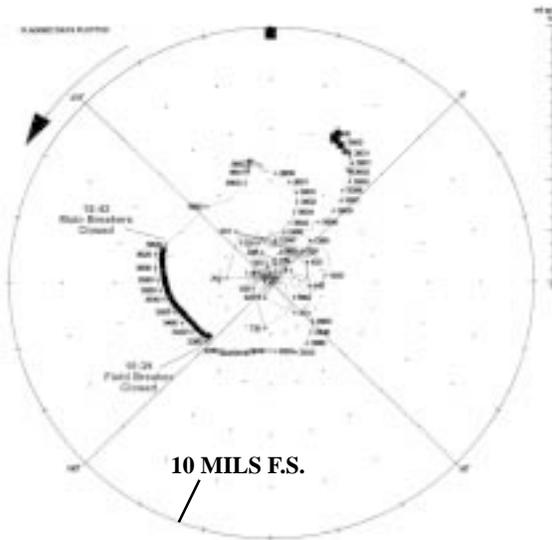
Figure 9: "Thermal Vector" Change During Field Excitation (GENFR)

As soon as the Field Breaker, and 3 minutes later, the Main Breaker were closed, vibration vector "took off" by almost 10 mils (Figures 9, 10 and 11). It seems that vibrations settled at that point, but during the continued load ascending, the vibrations at first went lower, and then went back high, extending the original "thermal" vector jump (Figures 12, 13 and 14).

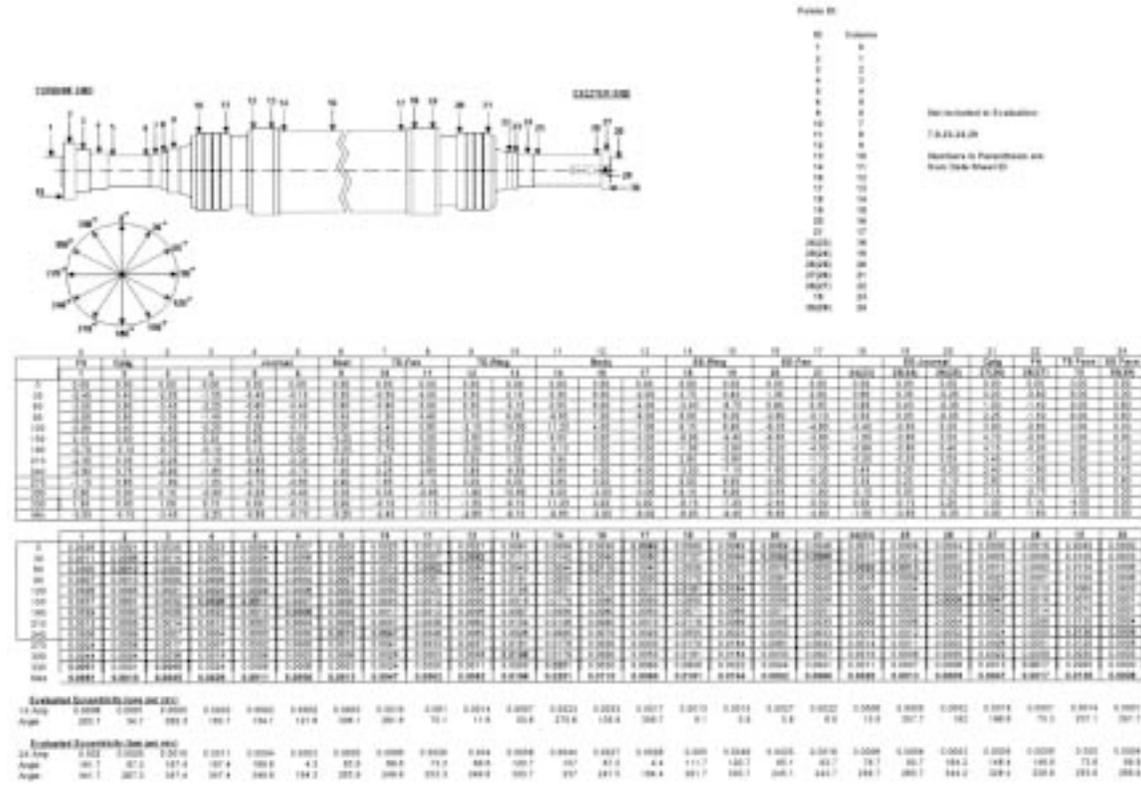
Figure 15: Generator Rotor Eccentricity Evaluation– Initial as Received in Shop

Total non-evaluated maximum TIR readings were high at many locations, but they are not an absolute indication that something is wrong with the rotor. This raw TIR data, after the analysis, yields the most important sets of information:

From this information the key points exceeding the acceptable 1x eccentricity limit set by the author can easily be seen:

- TE face ..... 0.0014" at 207°
- EE rim ..... 0.0018" at 197°
- Rotor Body:
- TE ..... 0.0023" at 275°
- Mid ..... 0.0033" at 106°
- EE ..... 0.0017" at 357°

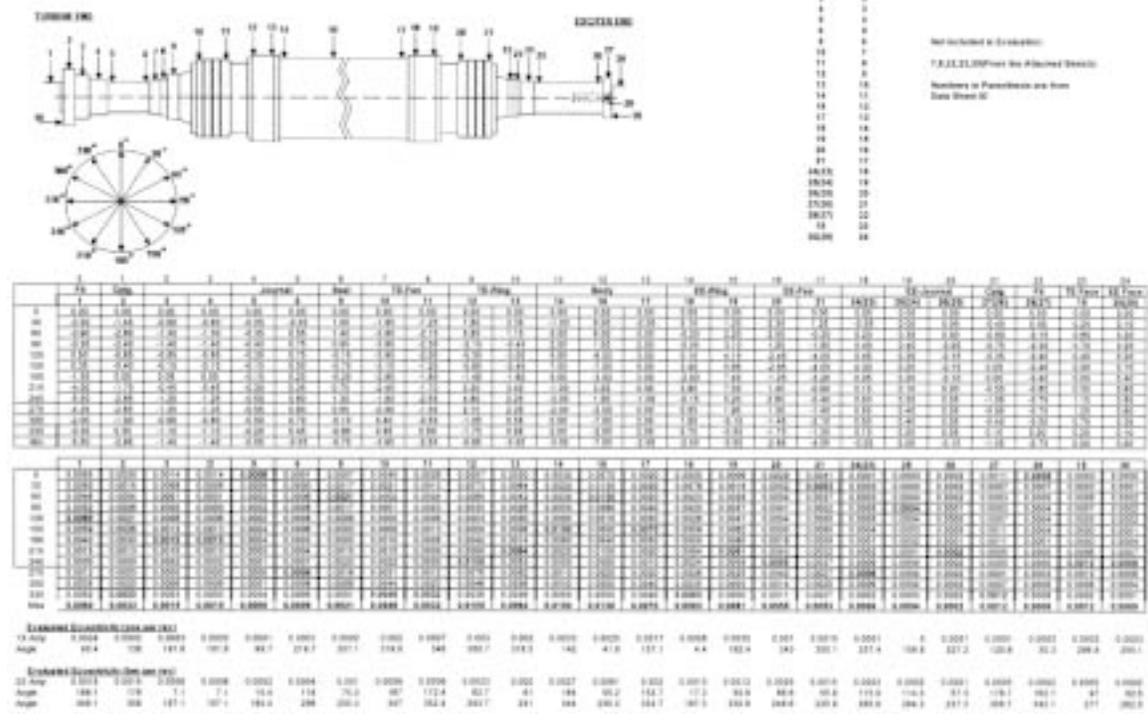
**Figure 16: Generator Rotor Eccentricity Evaluation– After Assembly and Before Balancing**

Some additional machining was done, based on as found recorded dimensional data, most likely to correct for deformation of TE coupling overhangs, after shrink fitting the TE fan hub. The key points used for comparison and an evaluation are:

- TE coupling spigot ... 0.0024" at 90°
- Rotor Body:
- TE ..... 0.0033" at 142°
- MID ..... 0.0025" at 42°
- EE ..... 0.0017" at 157°

The TE coupling spigot was left eccentric as reference to see if any change on the attached components (retaining rings and fan hubs) has shifted when exposed to high centrifugal forces during the overspeed test in the bunker. From the tabulated data above, we can see that the rotor body eccentricity readings, in comparison to "initial" readings, had shifted 0.003"-0.005", after journals and seals were machined to correct rotor free TE ends extension deformation.

This type of deformation is possible when the shrunk-on component, like fan hub, is not cooled uniformly during the cooldown process.

It is the author's opinion, when such deformation is observed, that it is better to again reheat and cooldown the rotor and hub uniformly (preferably slowly rotating), rather than to machine out the deformation.

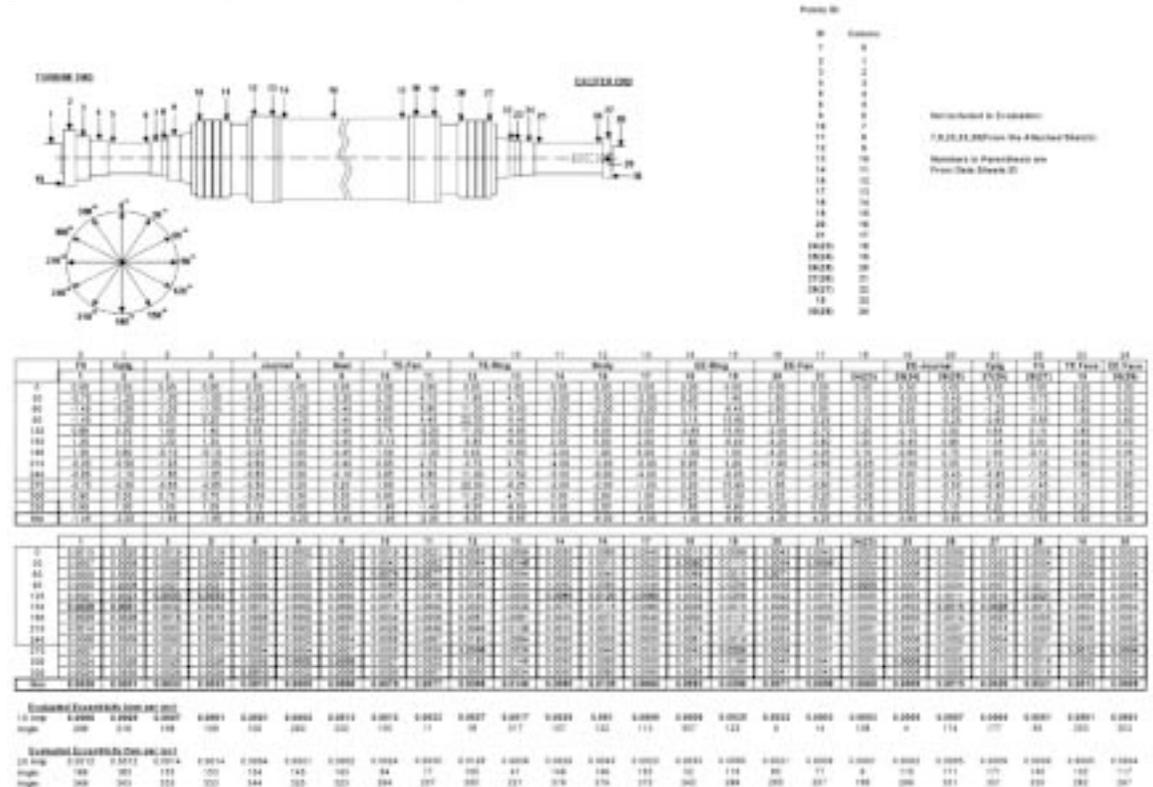
Figure 17: Generator Rotor Eccentricity Evaluation– After Balancing

There was no major change in TE coupling center shift during balancing, and the spigot was machined to match the centers of the coupling, journals and seals, to facilitate the alignment in the field. The key readings after balancing were:

Rotor Body:  
 TE..... 0.0029" at 107°  
 MID..... 0.001" at 122°  
 EE..... 0.0009" at 357°

All other readings were good and acceptable by the recommended criteria. It is noted though, that body eccentricity readings were somewhat reduced in comparison to readings before balancing.

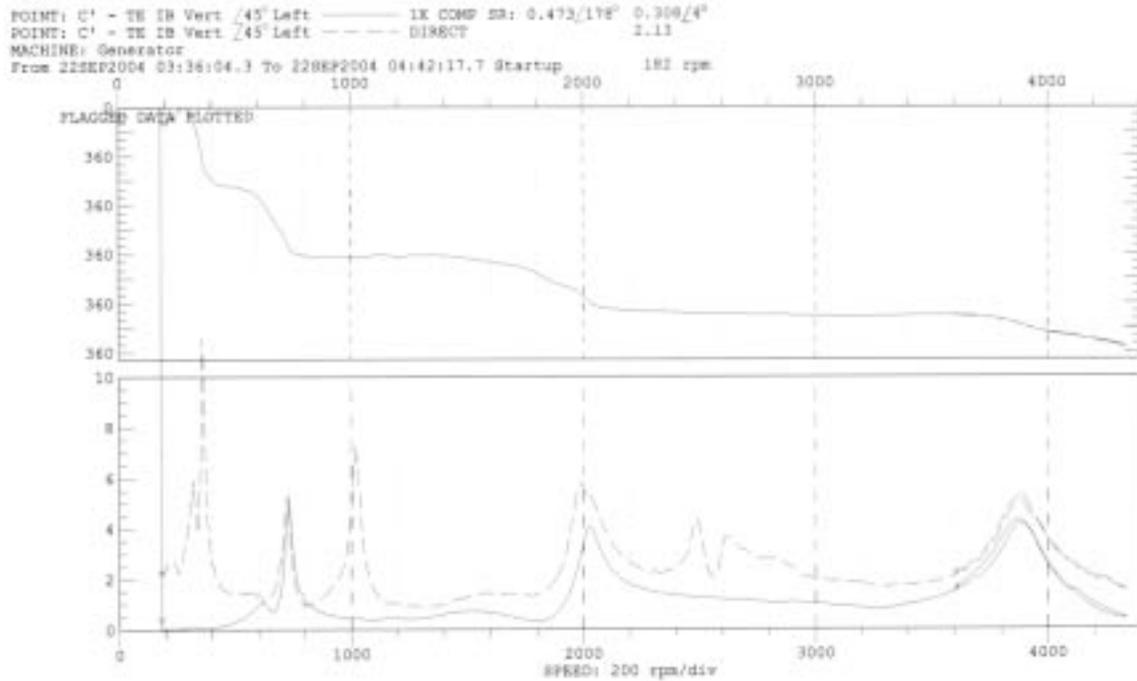
**Figure 18: Third Critical– Not Balanced (GEN-FRONT)**

The final balancing results in the bunker were very good. Three things were never-the-less somewhat peculiar:

- First critical speed on this rotor at 720 RPM was practically not visible.
- Second critical at 2000 RPM was also suppressed.
- Third critical at 3860 RPM was not fully balanced. (Figures 18 and 19)

In such cases it is extremely crucial to minimize the rotor body eccentricity. From the author’s experience, Body eccentricity should be less than 0.002”. Balancing should be done by N+2 method, or the third critical, which appears in the bunker at 3860 RPM should have been balanced much better than it was. That way the correction for the first mode should not be able to excite the third mode.

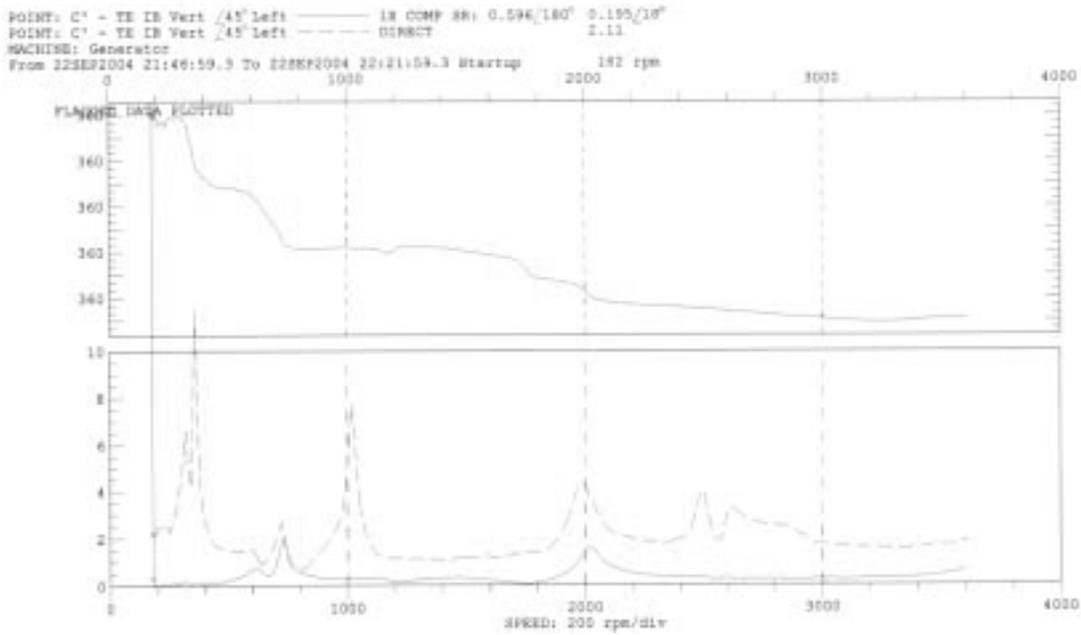
**Figure 20: “Final Balance” in Bunker (GEN FRONT)**

Never-the-less, the rotor “fulfilled” the contractual criteria and was released for shipment to the plant. (Figures 20 and 21)

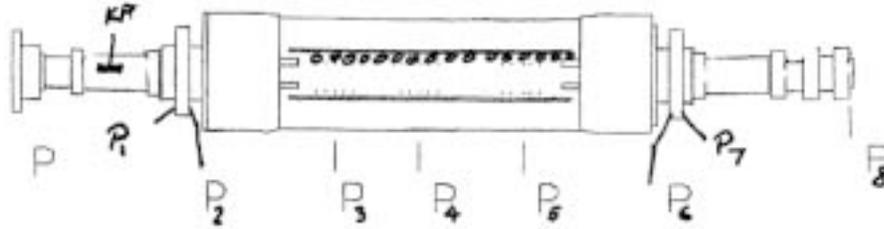
**Figure 22: Final Distribution of Weights in “Body” (~24 lbs.)**

The one thing that stands out up to this point was the amount and distribution of balancing weight in the rotor body. There was ~24 lbs of weight used for correction of the first critical speed, distributed across the full length of the rotor body. (Figure 22)

In reality what happened in this case is that the first mode balance correction weights distorted the body to bring the total sum of rotor mass into rotational centerline.

The distorted rotor balanced condition formed a bow in the middle of the rotor body.
