Runout Measurements with Non-Contact Probes, and FE Modeling, Tools in Root Cause Analysis (II)

Zlatan Racic

Z-R Consulting • Bradenton, FL

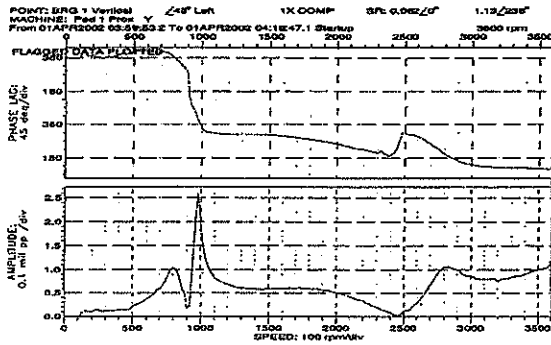
Figure 4. BODE plot bearing #1 vertical

The rotor was balanced in the Bunker to below permitted and required residual unbalance limits, and data was witnessed and recorded. (Figs. 3–12).

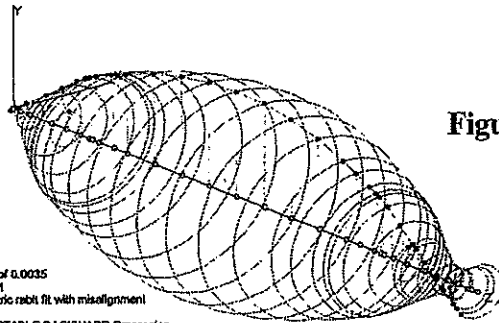
Figure 21. Modeling-- TE coupling to bearing

The eccentricities were needed to be introduced in the model as the only excitation driver to produce simulated amplitudes and a whirl mode to match the actual ones. This model had shown that due to coupling eccentricity to generator journals, a “dynamic” unbalance response and a corresponding whirl mode would not allow successful balancing at all speeds, i.e., at criticals and at operating speed using only two balancing planes. The original unbalance response and two field balancing attempts were simulated. (Figs. 20–24).

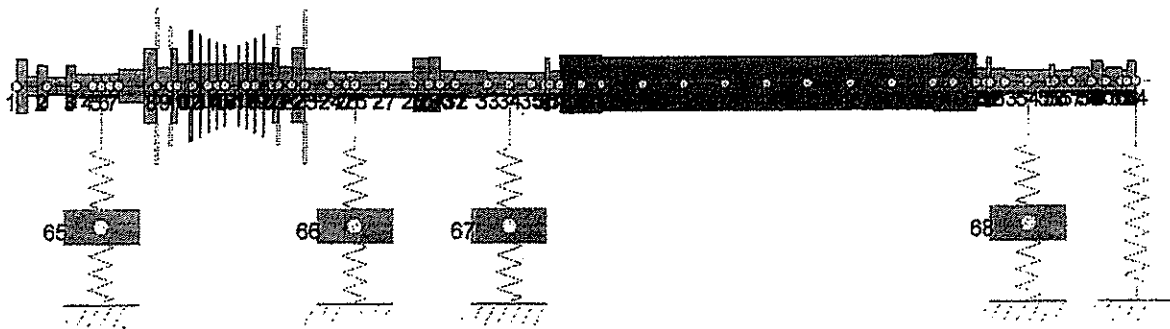
Figure 25. Modeling– generator shaft journals eccentricity at both bearings

An additional model simulation was performed with LP and generator rotors connected. (Figs. 25-31). The undamped criticals speeds produced give us the modes to be anticipated in the field. These eigenvectors reveal that balancing of the generator rotor cannot be achieved without extending balancing to additional planes on the rotor train. This model could be used as an answer to a question, raised during the vibration problem investigation: “Why could we not balance the generator at least to pre-outage condition”?
