# **Vibration Measurements and FE Modeling Tools in Root Cause Analysis (I.)**

**Zlatan Racic**

Z-R Consulting

This paper covers a case history of a generator rotor which went through extensive repair and modifications. Despite a great effort in following the work processes and quality control in the shop and with successful completion of repairs and high speed balancing (solo) in the bunker, the rotor exhibited unusual behavior when installed in the field. Vibration of any machine is only a symptom which in a traditional approach is treated by “balancing”, very often without ever discovering the root cause of the vibration. Treating the vibration process as a symptom, and diagnosing it for its root cause, is the topic of this paper.

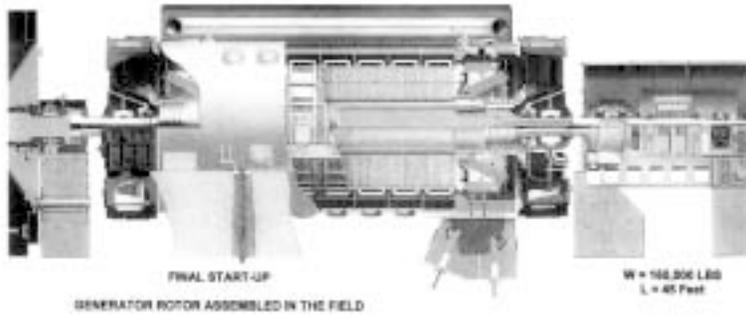
**Figure 19A: Generator Rotor Cross Section**

The calculated mode shapes of the rotor using DYROBES®, closely match those in the bunker (Figures 19a, b ,c, d, e).

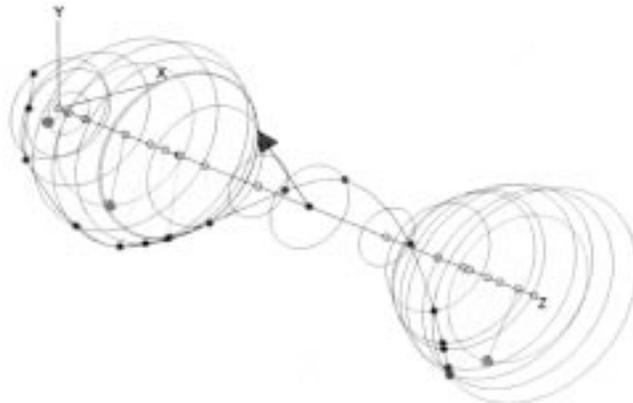
**Figure 19E: Rotor Calculated Damped Deflection Shape at 3600 RPM**

The problem observed with this particular rotor can be traced back to its extreme flexibility and operating above third critical mode. Actually its operating deflection mode is at exactly the third critical.
